Shoreline changes

- at river and tidal entrances

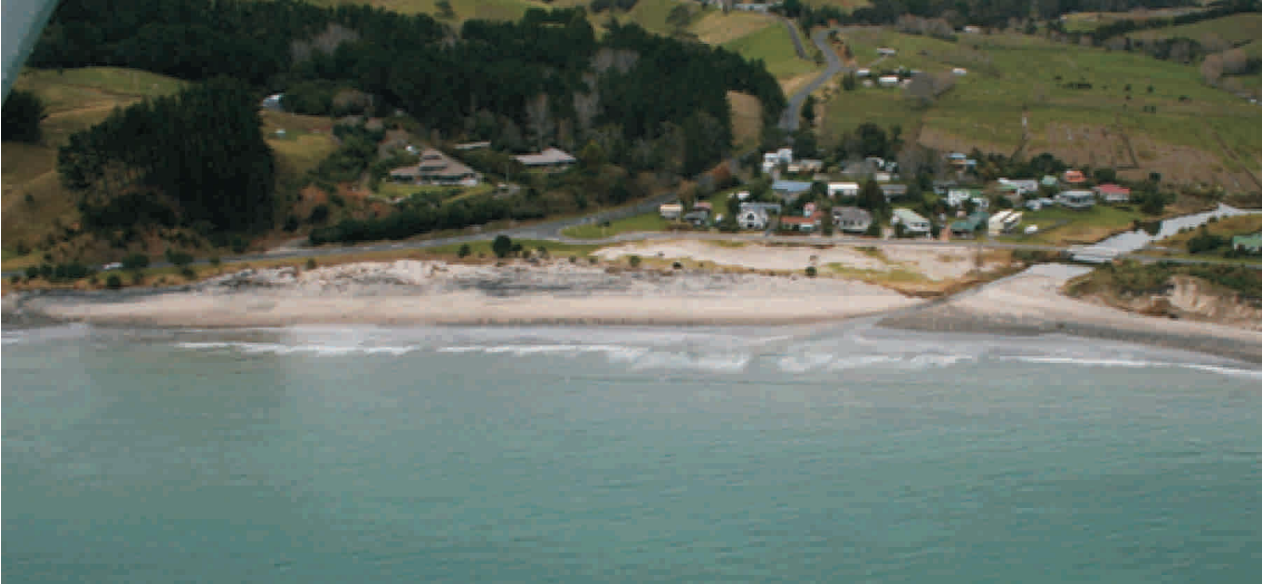
Figure 1: Pitoone Stream discharging near centre of Kuaotunu West Beach, eastern Coromandel. In its natural state the stream periodically migrated 300 metres further east (to the left of the photograph).

For instance, Figure 1 shows Pitoone Stream which discharges near the centre of Kuaotunu West Beach on the eastern Coromandel. Under natural conditions the stream would often migrate 300 metres to discharge adjacent to the headland at the eastern end of the beach (far left of top photo), particularly during low or normal flow conditions. This alongshore migration eroded and reworked beach and dune deposits over a width of more than 50 metres,

lowering this area and exposing areas to landward to increased wave action. Floods would often return the entrance to the centre of the beach.

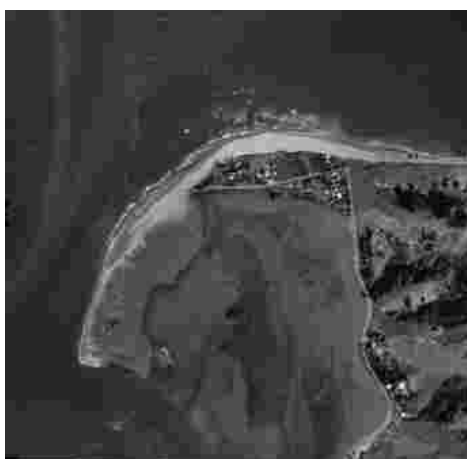
Figure 3: Aerial photos of Ohiwa Spit (southern side of Ohiwa Harbour entrance, Bay of Plenty) showing the large-scale shoreline fluctuations which can occur in these near entrance locations. The black and white photo dates from 1979 and shows the spit during an erosion period – with the shoreline having eroded back into the township affecting several properties. In 2011 (colour photo), the shoreline in front of the township was in an accretionary state - having advanced by 150-180 m. At this site, these large scale shoreline fluctuations have a period of about 50-70 years (i.e. the time from severe erosion to an accreted state and back to severe erosion). These large scale fluctuations will continue over time and in the future the shoreline will erode back into the township as it did in the

Ohope Spit enclosing Ohiwa Harbour in the southern Bay of Plenty is another example (Figure 3). Gibb (1977) estimated that the Ohiwa Harbour entrance migrated 346 metres eastwards between 1867 and 1976 in response to longshore extension of the Ohope Spit. Ohiwa Spit on the southern side of the entrance eroded as the spit advanced (Smith, 1976; Gibb, 1977). The entrance to Opotiki Harbour (the river mouth of Waioeka and Otara Rivers) is presently 900-1100 metres west of its position in 1866, with upstream channel changes contributing to this alongshore movement (Dahm and Kench, 2002). Many other similar changes have been observed around the New Zealand coast over the last century.

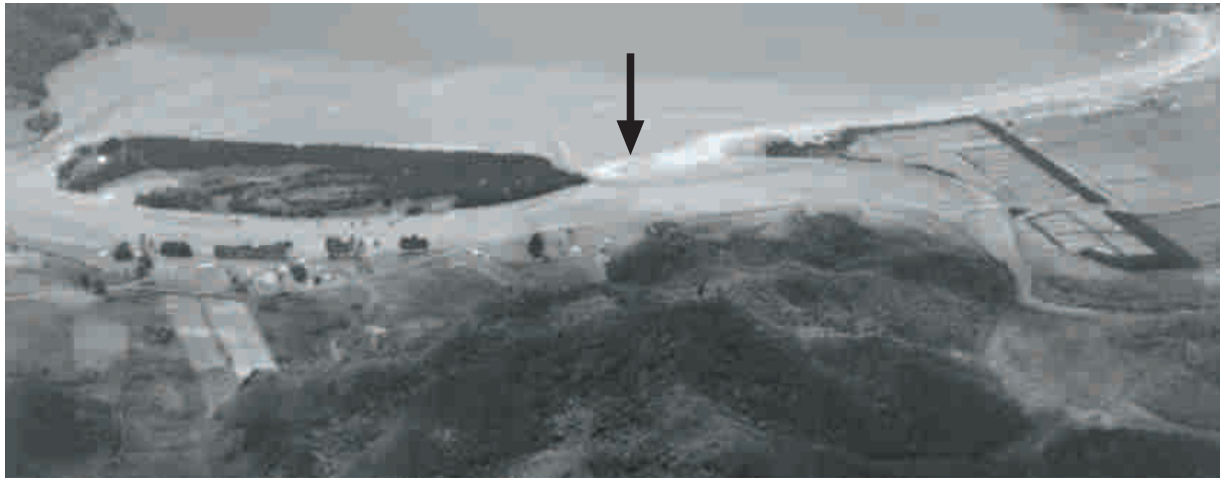
Figure 4: Example of spit breach. Aerial view of Kennedy Bay sand spit taken in 1982 – showing a second entrance (arrow) formed by a spit breach. The normal entrance is further north (far left of photo). The breach was eventually closed by human action. Left to natural processes, the second entrance may have gradually migrated northwards eroding the forested land between or it may have closed naturally.

Other examples of significant spit breaches over the past century include Maketu Estuary on the Bay of Plenty coast (Rutherford et al., 1989) and Kennedy Bay (Figure 4) on the northern Coromandel (Dahm

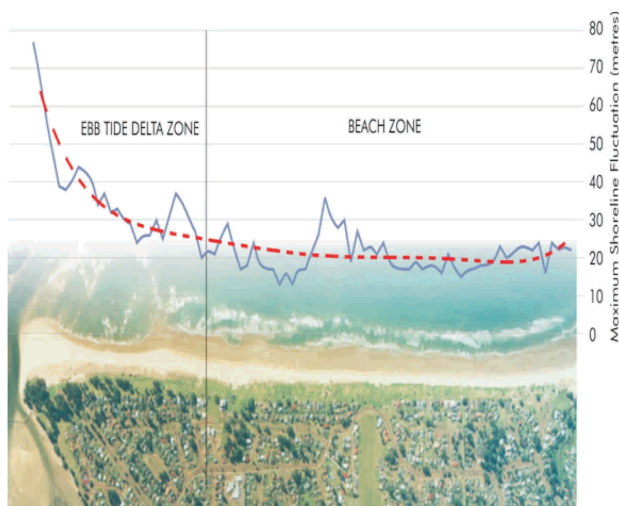
Figure 5: Maximum shoreline change recorded along Pauanui Beach between 1895 and 1995, Coromandel. Shoreline change is greatest nearer the harbour entrance.

The active sediment exchange between flood and ebb tide deltas and adjacent shorelines results in significant shoreline fluctuations close to tidal entrances. Figure 5 shows the maximum shoreline changes recorded along Pauanui Beach using historic surveys dating from 1895 to 1995 – based on data from Dahm and Munro (2002). It can be seen that the maximum change near the harbour entrance (over 75 metres) is over three times the typical values (20-25 metres) noted in beach areas further removed from the entrance. The occasional higher spikes away from the entrance coincide with stormwater outlets.

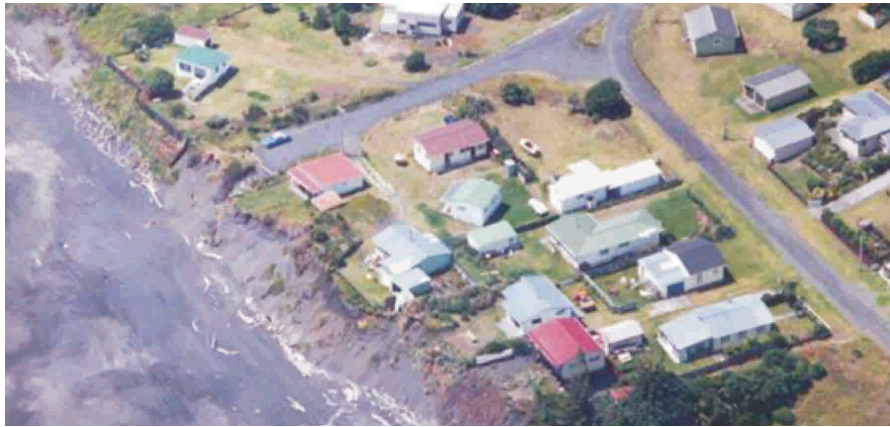
Figure 7: Mokau spit - properties and dwellings threatened by erosion in mid 1990s as a result of significant fluctuations of the shoreline near the Mokau River entrance. (Photo: J Dahm).
