Restoring windblown dunes using native plants

Difficult sites case study - Ngarahae Bay, west coast North Island

Case Study 3 - Ngarahae Bay, west coast North Island

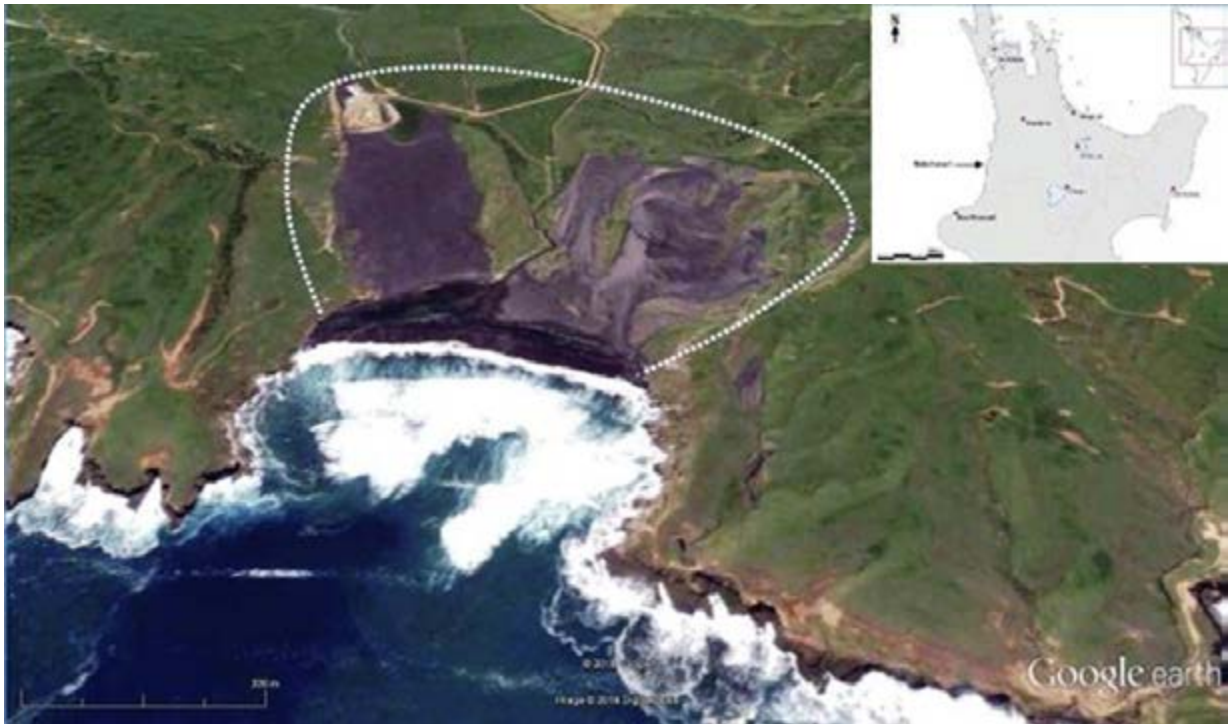
Figure 1: Oblique aerial view of part of Nukuhakari Station, southwestern Waikato Region, showing Ngarahae Bay (aka Middle Bay) study site, with sand sheets migrating inland.

Nukuhakari Station is a large sheep and cattle pastoral hill country station on the west coast between Awakino and Marokopa (Figure 1). The coastal margin of the farm has three sandy bays exposed to prevailing westerly winds, including the study site, Ngarahae Bay (Figure 1).

The original frontal dune along the seaward edge of the bay has been completely removed by wind erosion over many decades. This has exposed the underlying bedrock and, in places, a “coffee rock” comprising a dark coloured cemented sand layer that would originally have formed at the water table several metres below the original frontal dune surface. The large sand sheet in the background is migrating sand.

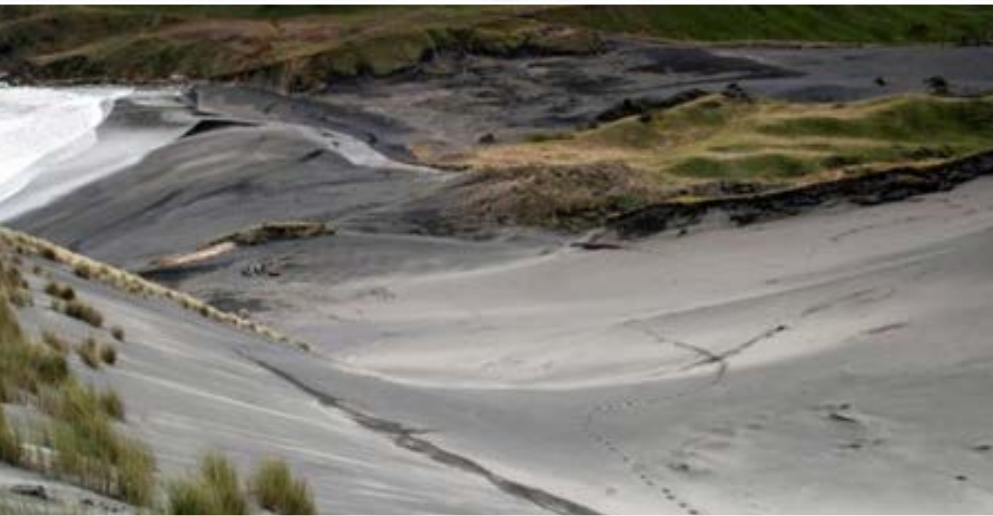
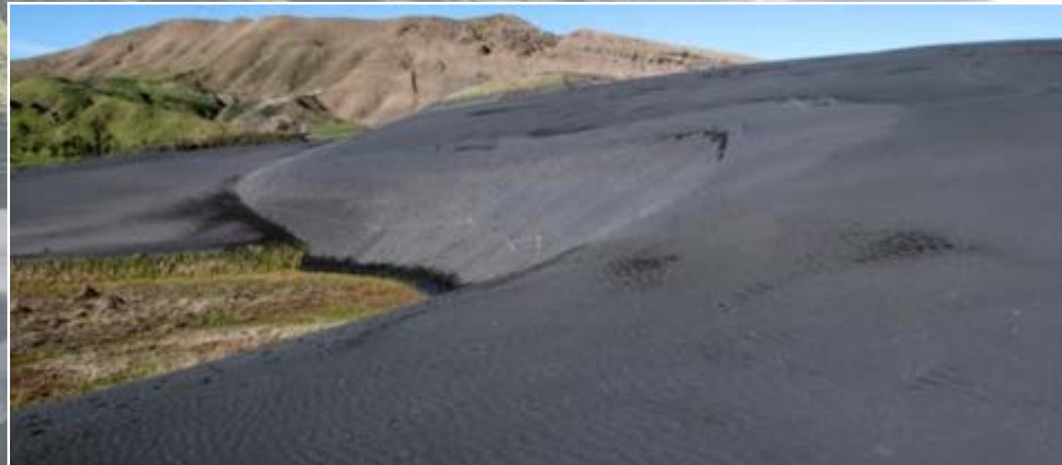
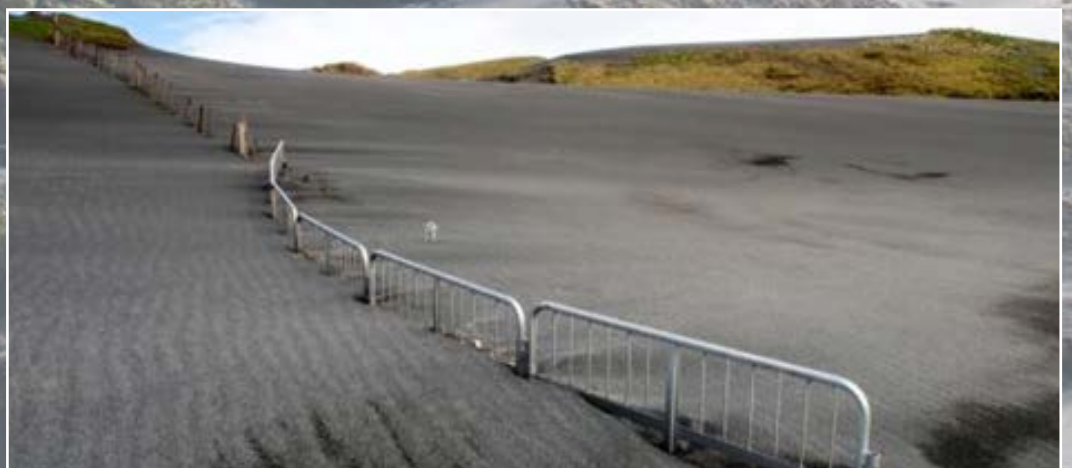
Figure 2: Views of migrating sand sheets at Ngarahae Bay burying productive pastoral farmland.

Ngarahae Bay has two large sand sheets which are migrating inland, covering a total area of approximately 8 ha with an intervening stream and narrow grassed ridge (Figure 2). The sand sheets are continuing to slowly move further inland over adjacent pasture.

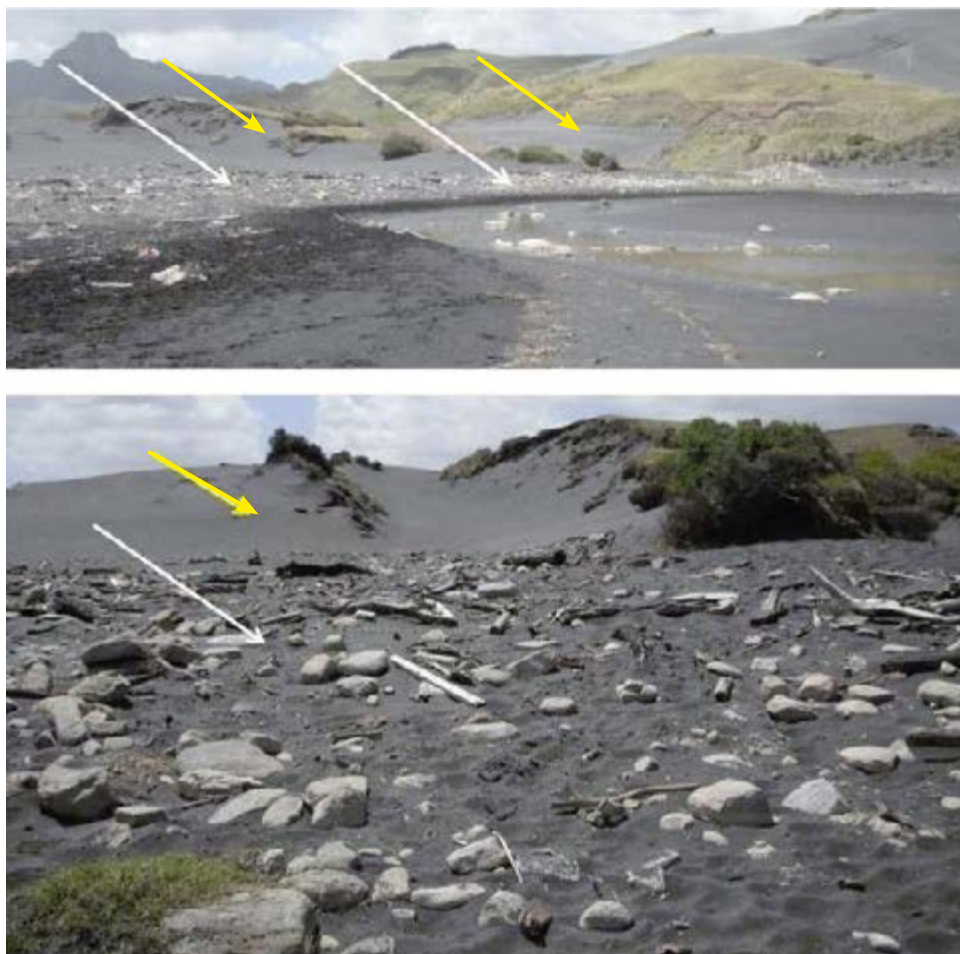
Figure 3: Views of lower more seaward dune area (arrowed in white) at the start of the project. Planting avoided these areas because of vulnerability to stream erosion (above) and storm wave inundation, (below) beginning near the toe of the higher dune (yellow arrows).

It is normal practice in the restoration of severely eroded dunes to start planting near the seaward edge and work inland. Otherwise, significant losses can be experienced due to burial by migrating sands. However, at this site, this approach had to be modified as the lower, more seaward dune area (Figure 3) was subject to periodic reworking - probably over several decades - from movement of the stream mouth.

There was a risk that restoration of the most seaward dune area could be lost by stream erosion before the vegetation had a chance to spread laterally into adjacent dune areas. In addition, storm debris indicated that the seaward dunes, lowered by historic wind and stream erosion, were vulnerable to periodic wave inundation. This would increase plant losses during the establishment phase. In addition, the sand in this area was often limited to a relatively thin (often <0.1m) layer of very mobile sand over rock, less suitable for establishment of spinifex and pingao.

Accordingly, planting commenced at the seaward toe of the higher dune area immediately landward (see yellow arrow in Figure 3).

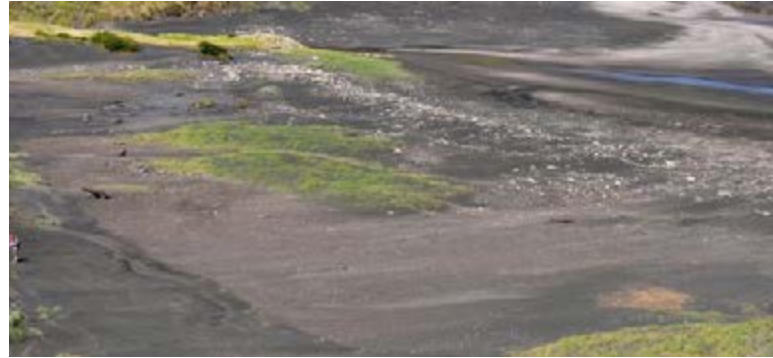
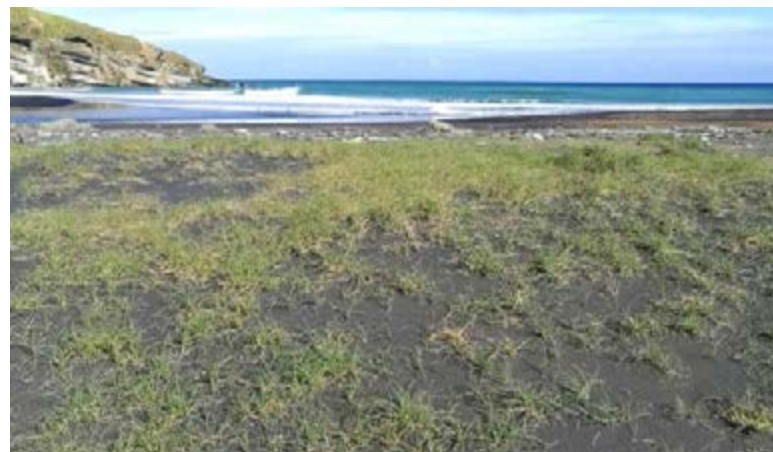
Figure 4: A patch of sand sedge on the low dunes at the seaward edge of the site (above). This species has expanded considerably since stock exclusion (below).

Interestingly, in the period following stock exclusion, the small patches of sand sedge began to spread more widely on the lower dunes (particularly in low-lying areas close to water tables), increasing dune height (Figure 4). This common pioneer species on the west coast of the North Island has the rhizomatous growth habit frequently encountered in pioneer and early seral

The natural expansion of sand sedge not only helped reduce the volume of sand blowing onto the new plantings further inland; it also created deeper dune sand more favourable to spinifex and pingao at a later stage of recovery. Once the incipient front dune is restored, it is expected that this spinifex and pingao-dominated dune will progressively move seaward, eventually displacing most if not all the sand sedge. As noted by Burgess (1984), sand sedge as an early coloniser is ultimately “doomed to extinction on the sites it colonises”.

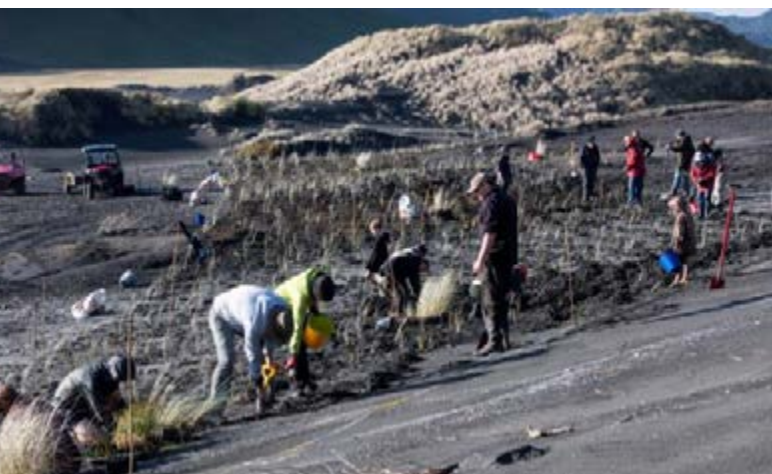
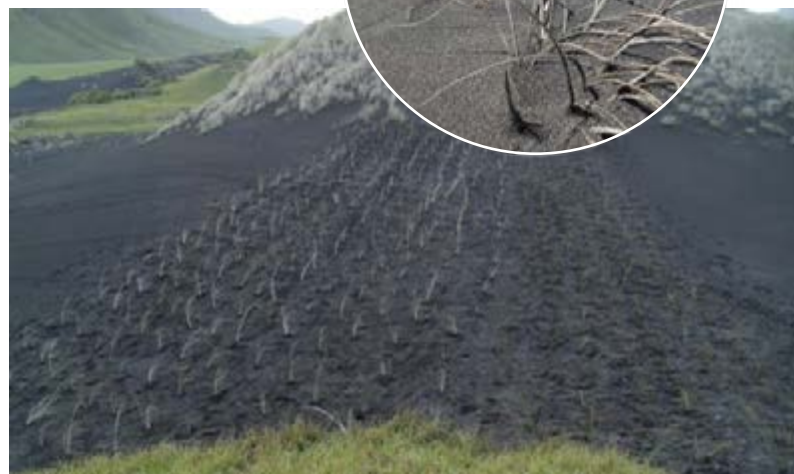
Figure 5: Views during (left) and after (right and inset) planting, showing the typical width of planting adopted at this site. Young spinifex seedlings (6 months old) subject to active burial. These plantings survived and thrived (inset).

No sand fences or other plant protection measures were used during the plantings. Rather, emphasis was placed on locating the plantings as far seaward as appropriate and establishing a sufficient width of planting (12-15m at this site) (Figure 5) to

accommodate windblown losses while maintaining a useful width of vegetated dune.

Losses tended to primarily occur along the seaward margin from sand blasting and exposure of roots. Burial by sand was limited by the location of plantings. Field inspections suggested that burial tended to stimulate and encourage plant growth once the plants were established, typically by mid-summer. However, if the plantings had been conducted further landward with higher volumes of onshore migrating sand, experience from other sites indicates that losses due to this factor would have been significant.

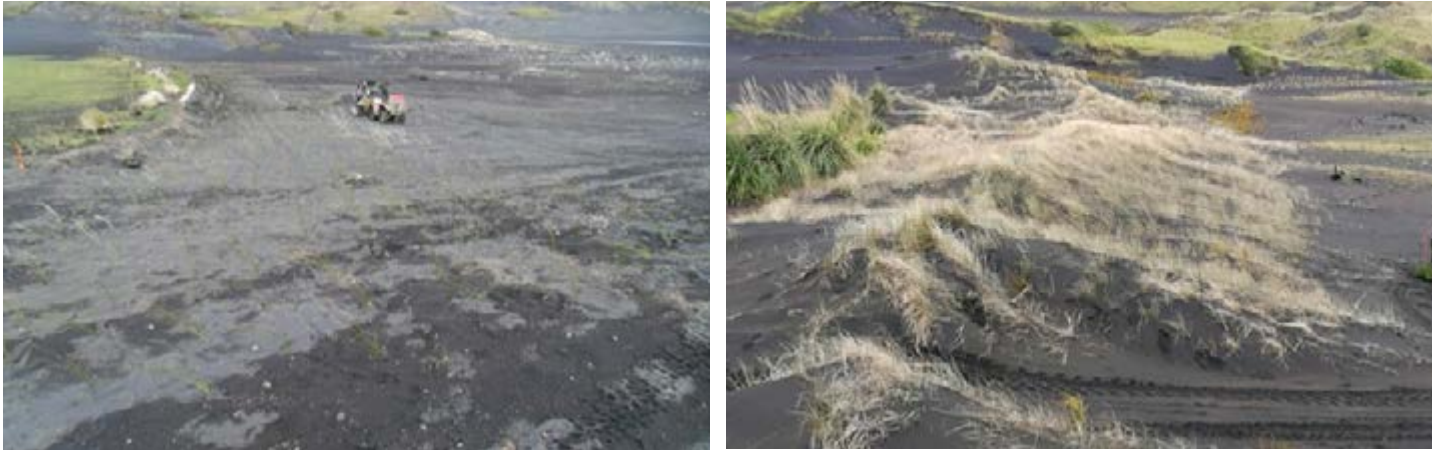
Figure 6: View of dune - initial planting (left) and 4 years later (right).

The initial project to establish an incipient frontal dune across the seaward edge of the embayment has been successful, with a well-established frontal dune now present (Figure 6).

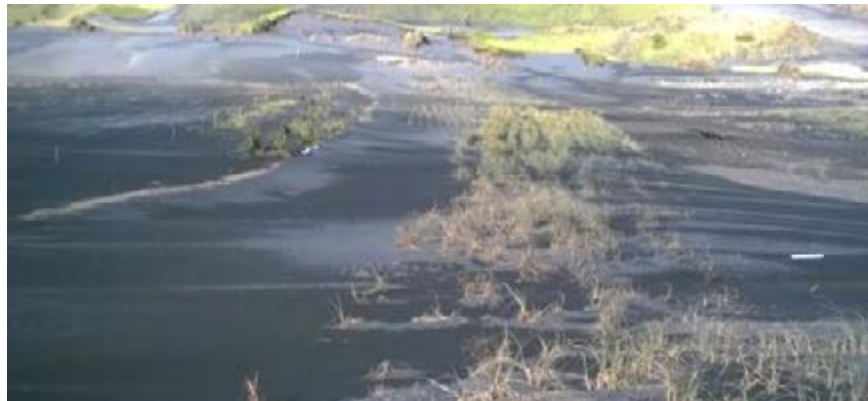
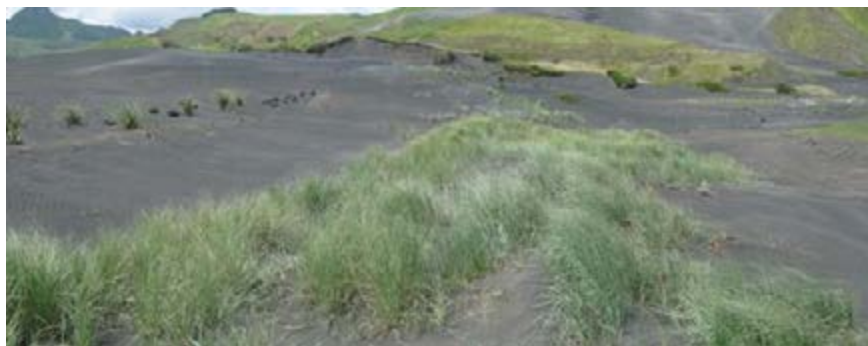
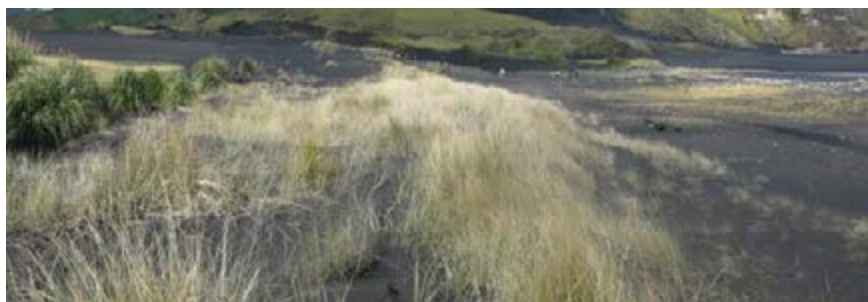
Figure 7: View showing dune establishment after 1 year (above), 2.5 years (middle) and 3.5 years (below).

The stages of foredune development over time are illustrated in Figure 7. Plantings often suffered significant losses in the first year. However, once these were secured by infilling gaps, the incipient dune feature was successfully established and expanded over time.

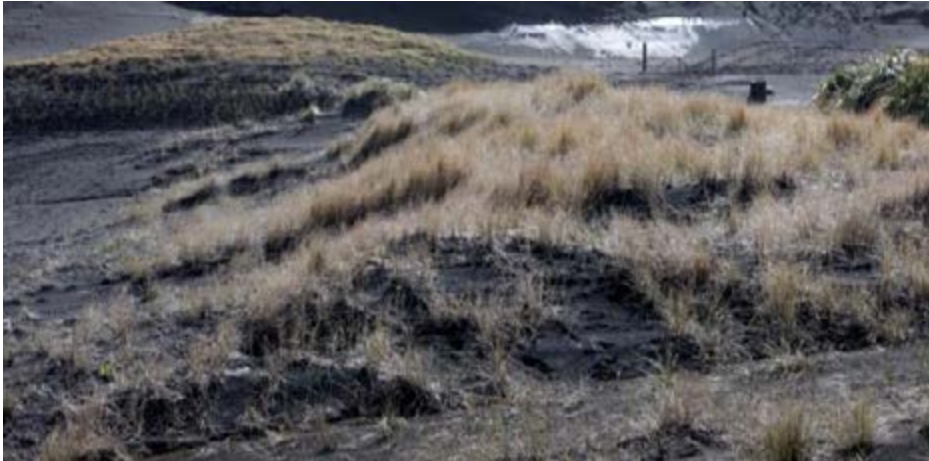
Figure 8: Close-up view of restored incipient frontal dune showing useful dune height developing. The planting in this area was 3 years old at the time.

Once established, the incipient front dunes generally showed rapid increases in height due to active sand trapping (Figure 8). In addition, spinifex stolons several metres long actively increased dune width both landward and seaward over time (Figure 9). In the oldest planted areas, these trends resulted in planted dune areas increasing in height by up to 1.5-2m and expanding in width by 10-15m in the 4 years since planting began. Provided that stock continue to be excluded from the area, this incipient dune will eventually extend seaward of the area of sand sedge (Figure 5), resulting in a foredune complex 100-150 m wide.

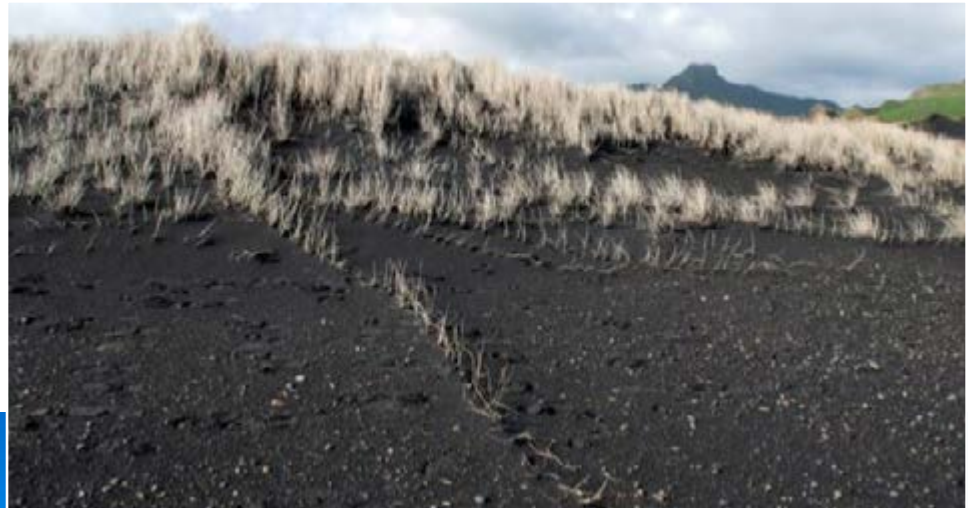
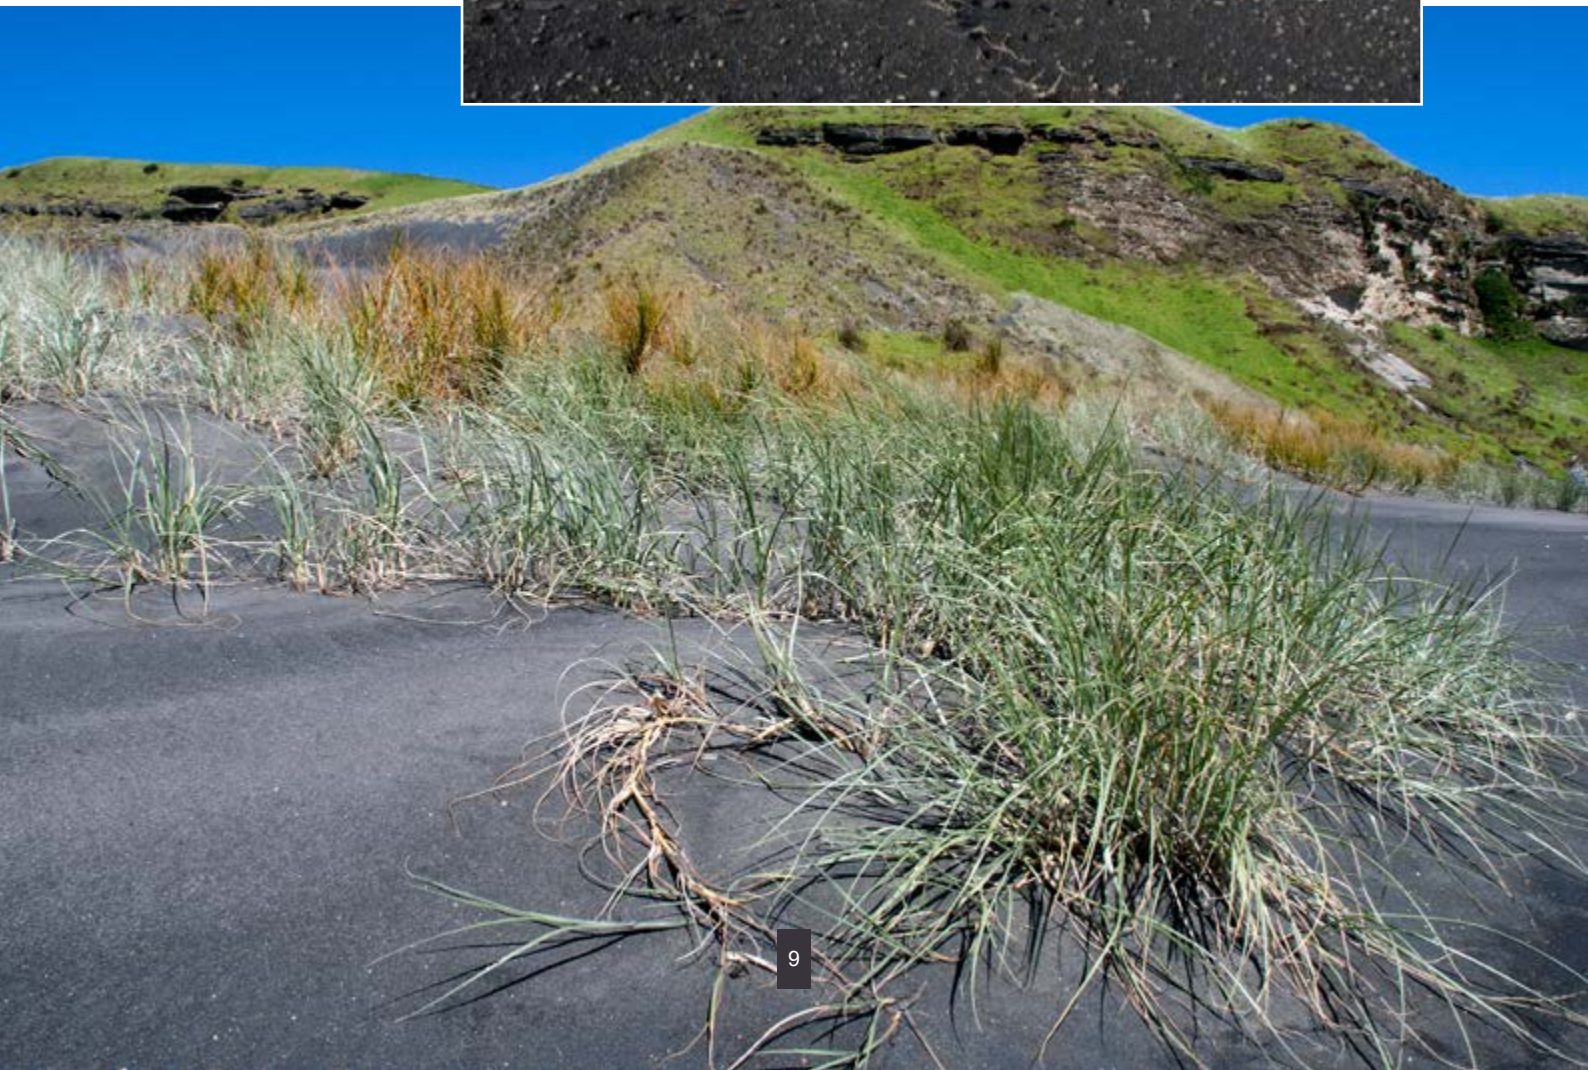
Figure 9: Established incipient dune showing *spinifex* stolons several metres long which are progressively extending the dune both landward and seaward over time.

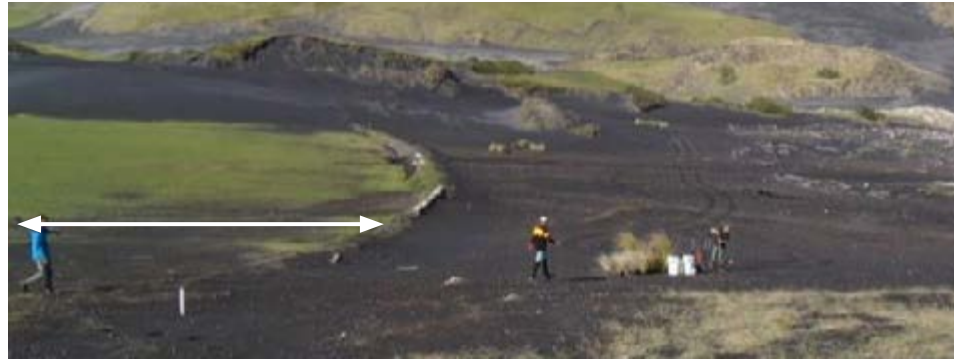
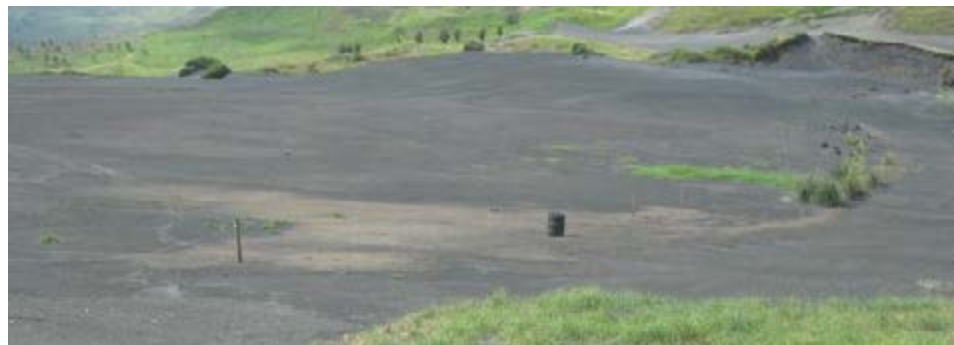
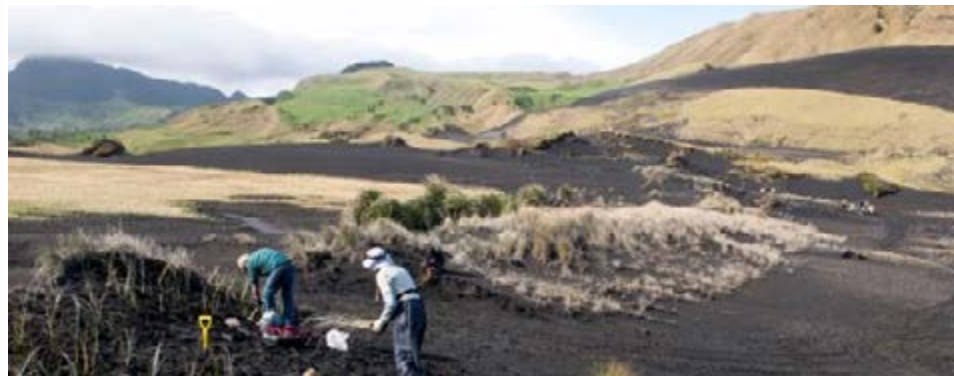
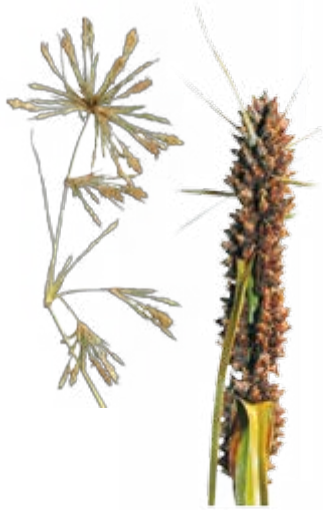
Figure 10: Views showing an area of pasture (arrowed in top photo) immediately landward of the restoration planting. This pasture was established on sands using a veneer of soil material sourced inland before the restoration (top) but was soon buried by moving sand (middle). However, once the incipient dune was established, onshore sand supply was markedly reduced and the pasture area was able to be used again (below).

The effectiveness of the incipient dune in cutting off sand supply to the migrating sand sheets further inland was demonstrated dramatically at this site. Before restoration began, pasture was restored in an area directly landward using oil drilling wastes (Figure 10 above), although this was soon inundated with migrating sand (Figure 10 middle). However, once the incipient foredune had been re-established, sand supply was dramatically reduced, with the result that the surficial sands were stripped off by onshore winds (migrating further inland) and the underlying pasture was once again exposed and able to be used (Figure 10 bottom).

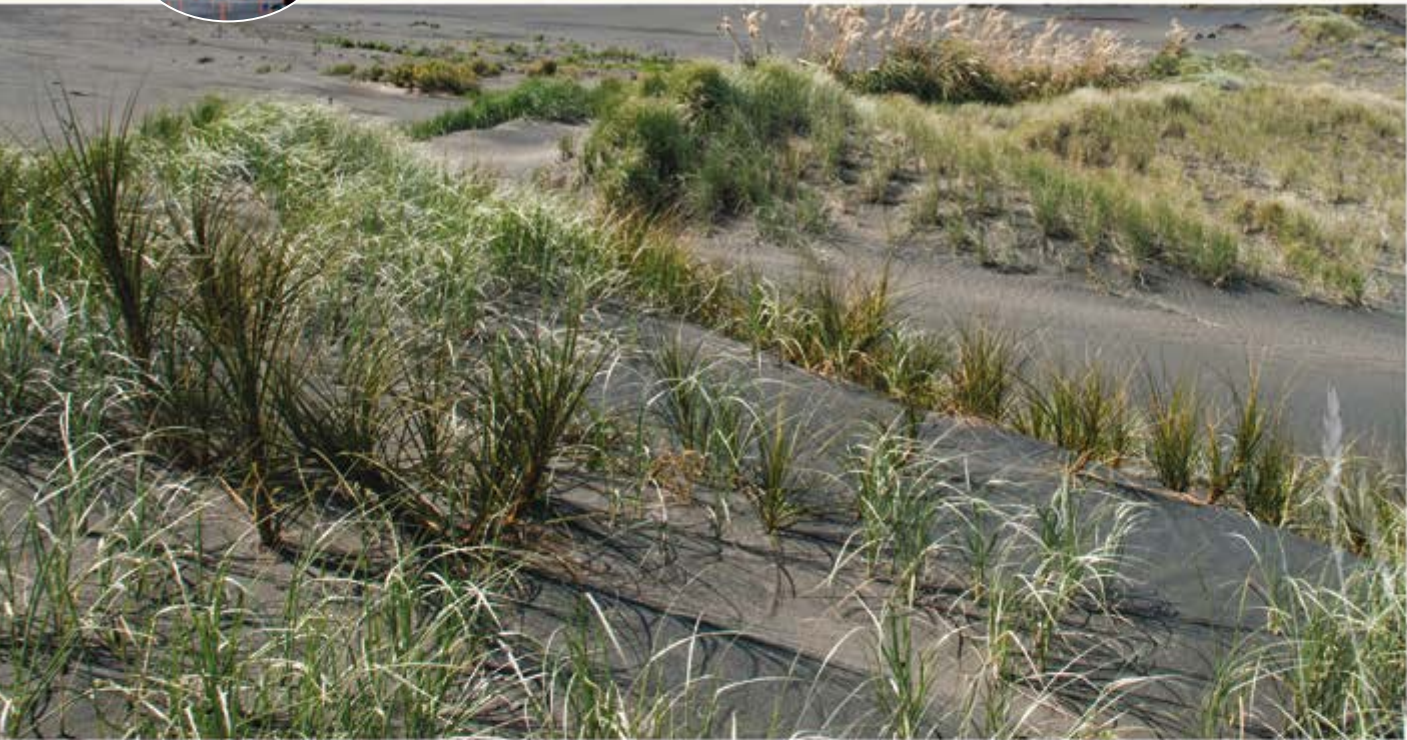
Figure 11: The native sandbinders *spinifex* and *pingao* proved to be the most useful in developing a zone of foredune vegetation, where strong winds and mobile sand characterise an environment typical of the west coast of the North Island.

Spinifex and to a lesser extent pingao, are the best species for initial stabilisation in these environments where grazing animal pests are not a serious problem. Early successional backdune species can probably be established successfully in sheltered backdune environments, but only once an initial pioneer cover of spinifex and pingao is established.
