# Increasing role of Coastal Restoration

Estuary Examples

Jim Dahm  
Eco Nomos Ltd

**Kaituna River Re-diversion  
and Te Awa o Ngātoroirangi  
/ Maketū Estuary  
Enhancement Project**

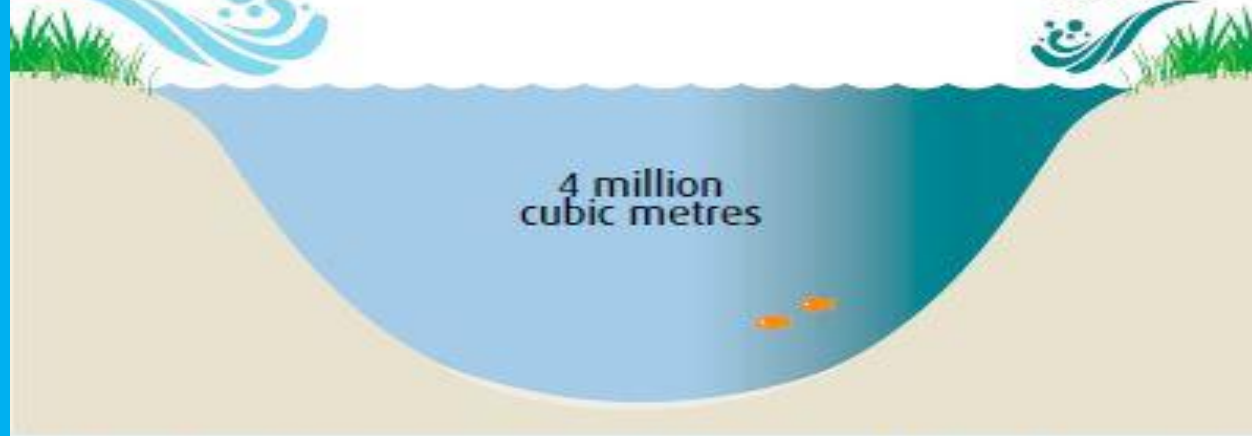
Maketū Estuary – 1955 before Te Tumu cut

River  
**75%**

Incoming tide  
**25%**

4 million  
cubic metres

*Before 1956 the estuary was mostly filled with freshwater from the Kaituna River.*

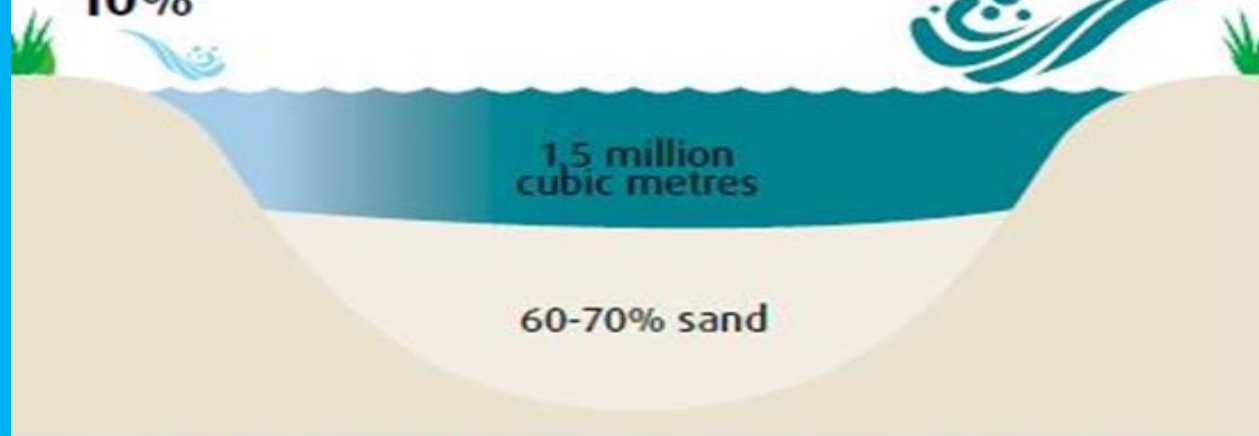
Maketū Estuary – Existing

River  
**10%**

Incoming tide  
**90%**

1.5 million  
cubic metres

60-70% sand

*After Te Tumu cut was built to divert the Kaituna River, the estuary filled mainly from the sea with each incoming tide. It's*

- Became totally saline estuary – upper reaches used to be freshwater wetland which quickly died out
- Major expansion of flood tide delta in lower estuary reducing tidal prism and causing shoreline erosion
- Reductions in kaimoana and other life
- Significant adverse cultural effects
- Extensive loss of intertidal wetlands (particularly rushland) and sea grass beds
- Markedly reduced circulation and flushing in the upper estuary and increased nutrient loads from land leading to problematic algal growths and anoxic sediment
- Reduced the natural flushing of sand and mud

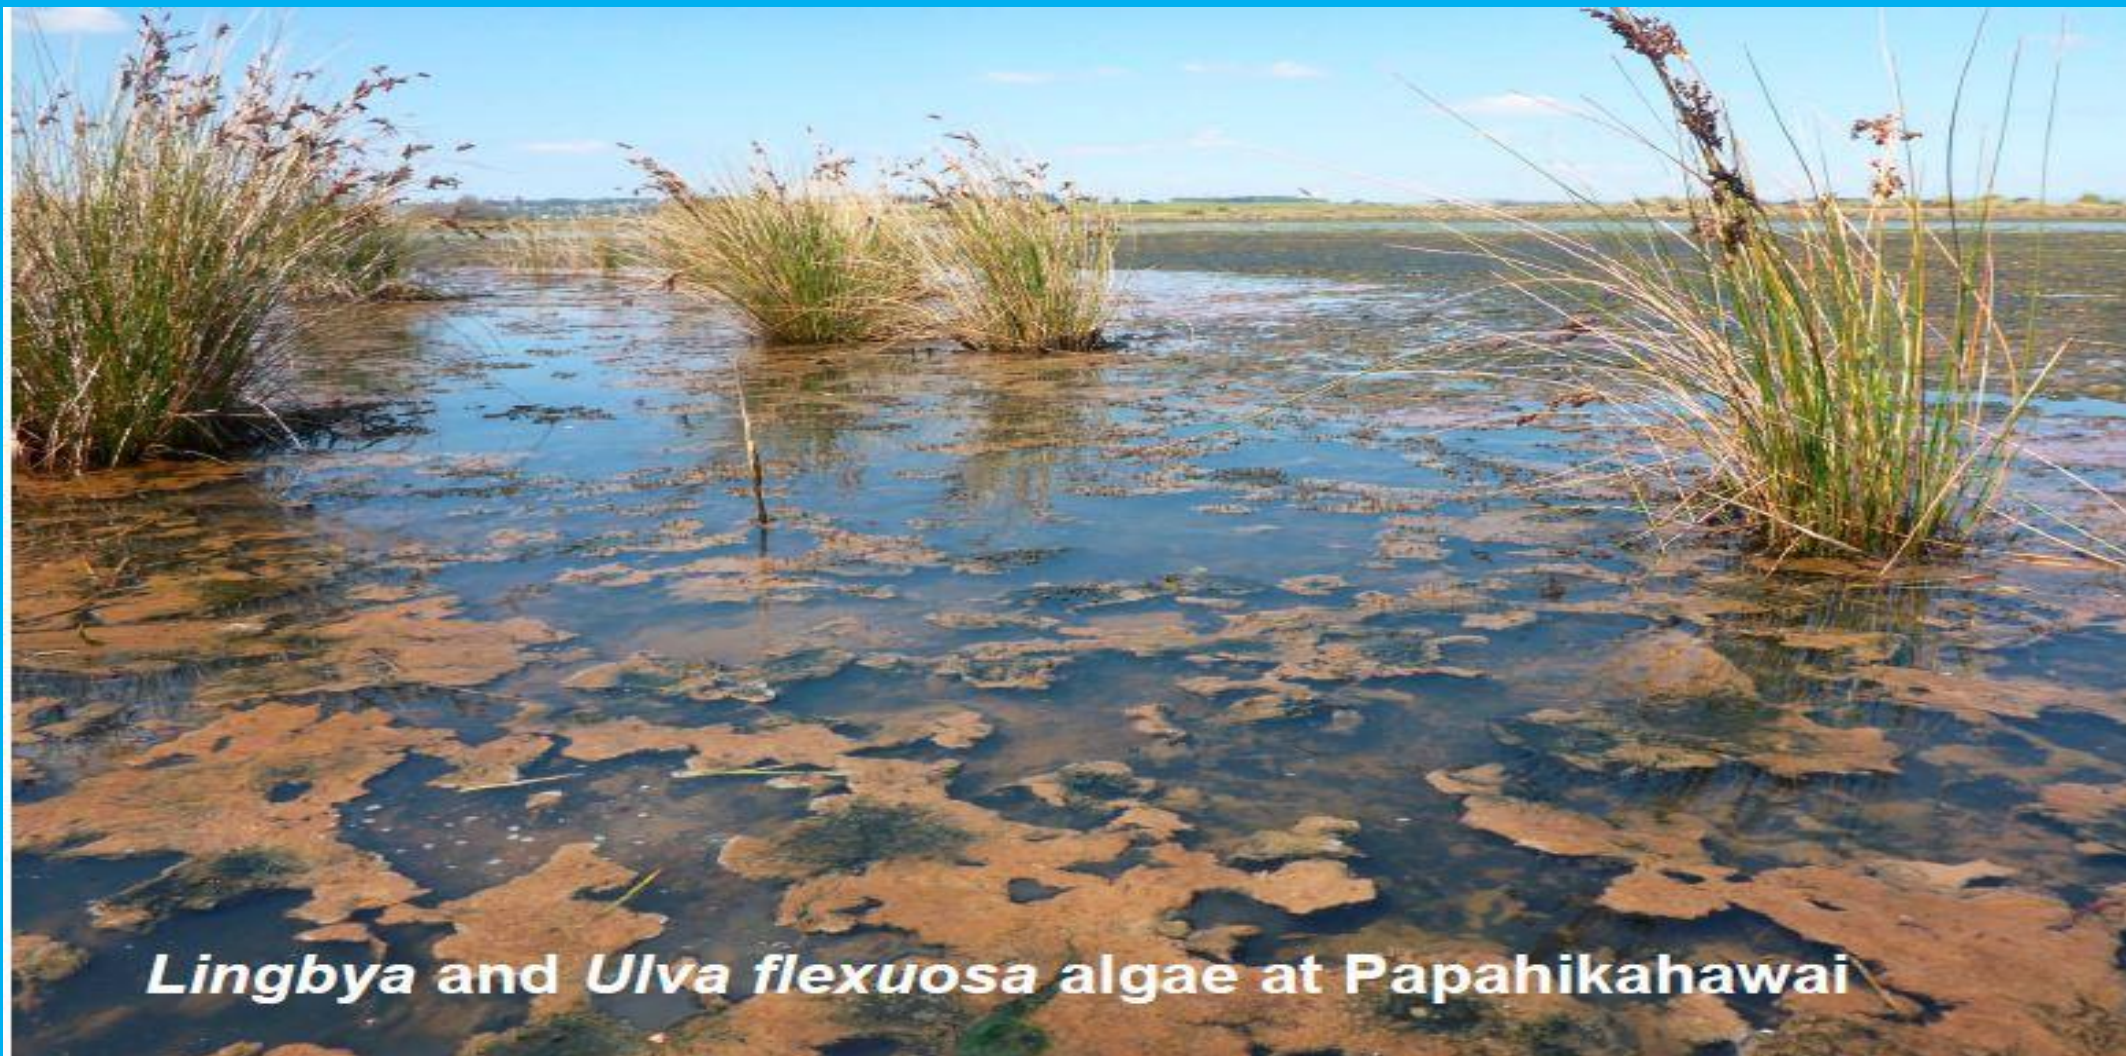
# Maketu - Problematic Algal Growths

- Concentrations of nutrients such as phosphorus and nitrogen are high in the upper estuary
- Nutrients stimulate growth of algae, such as sea lettuce, Gracilaria and benthic cyanobacteria.
- Prolific algae growths in the mid and upper estuary
- Also cause large fluctuations in dissolved oxygen levels, with daily minimum dissolved oxygen levels too low to support healthy fish.

***Lingbya* and *Ulva flexuosa* algae at Papahikahawai**

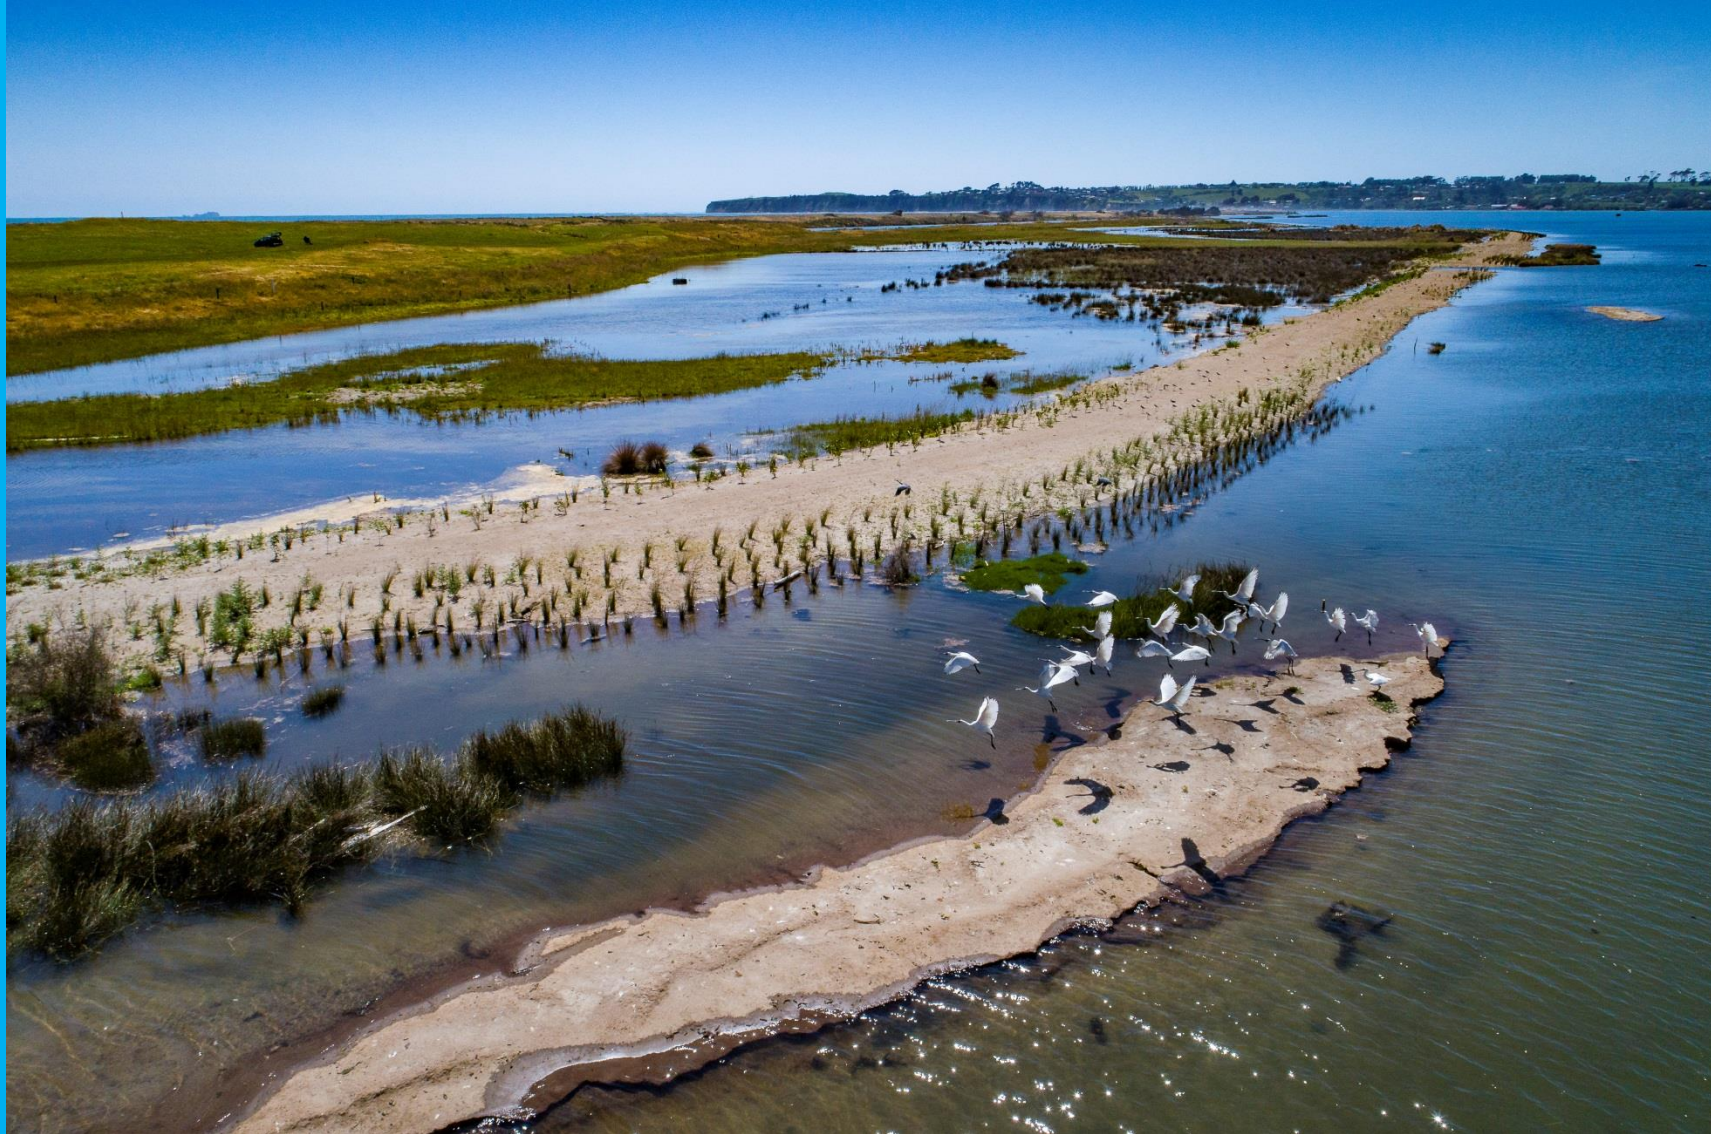
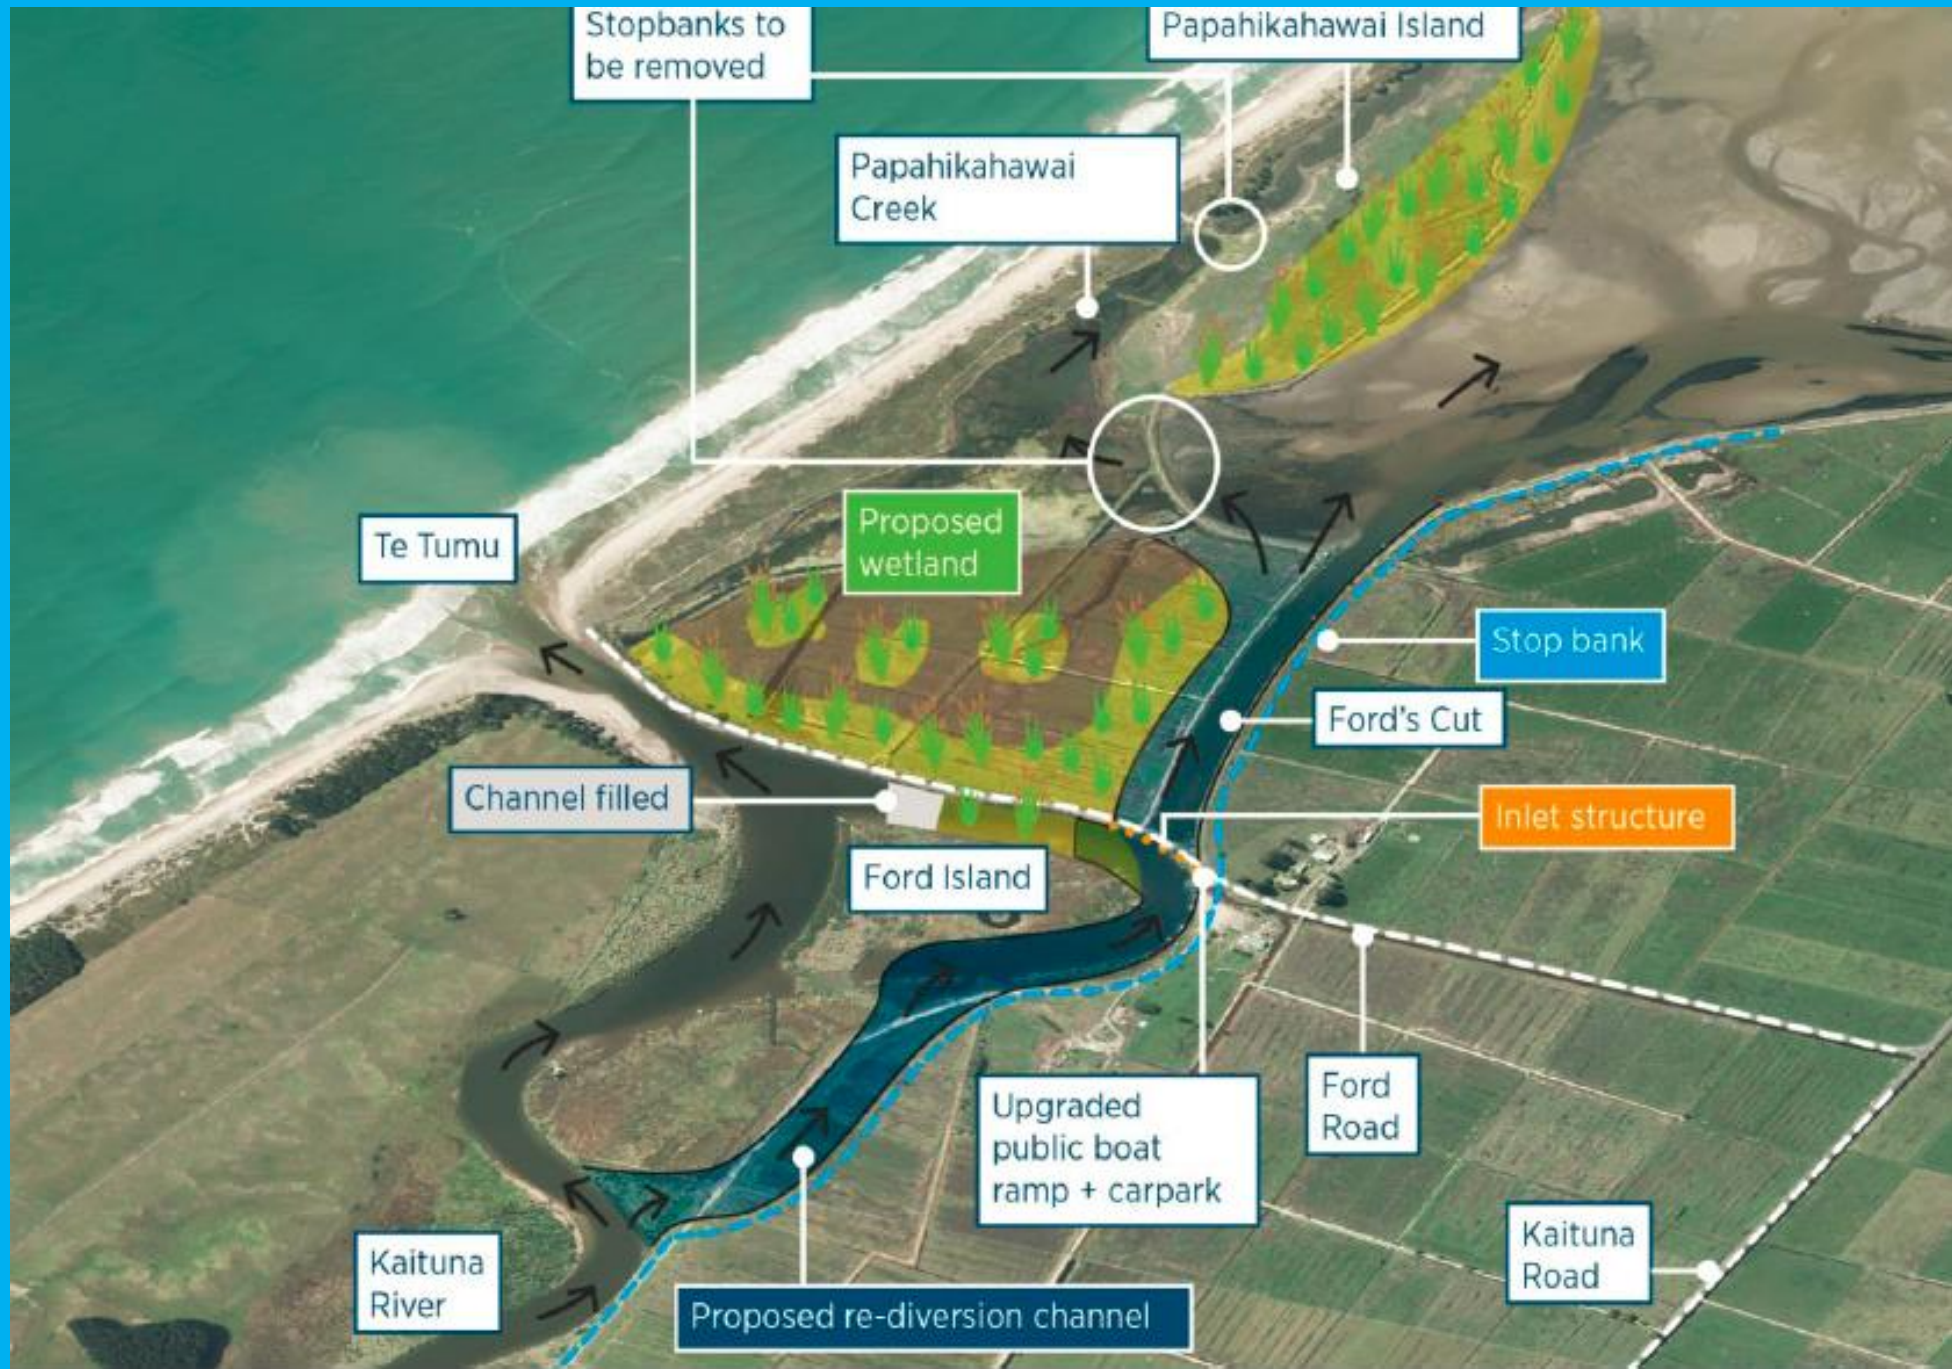
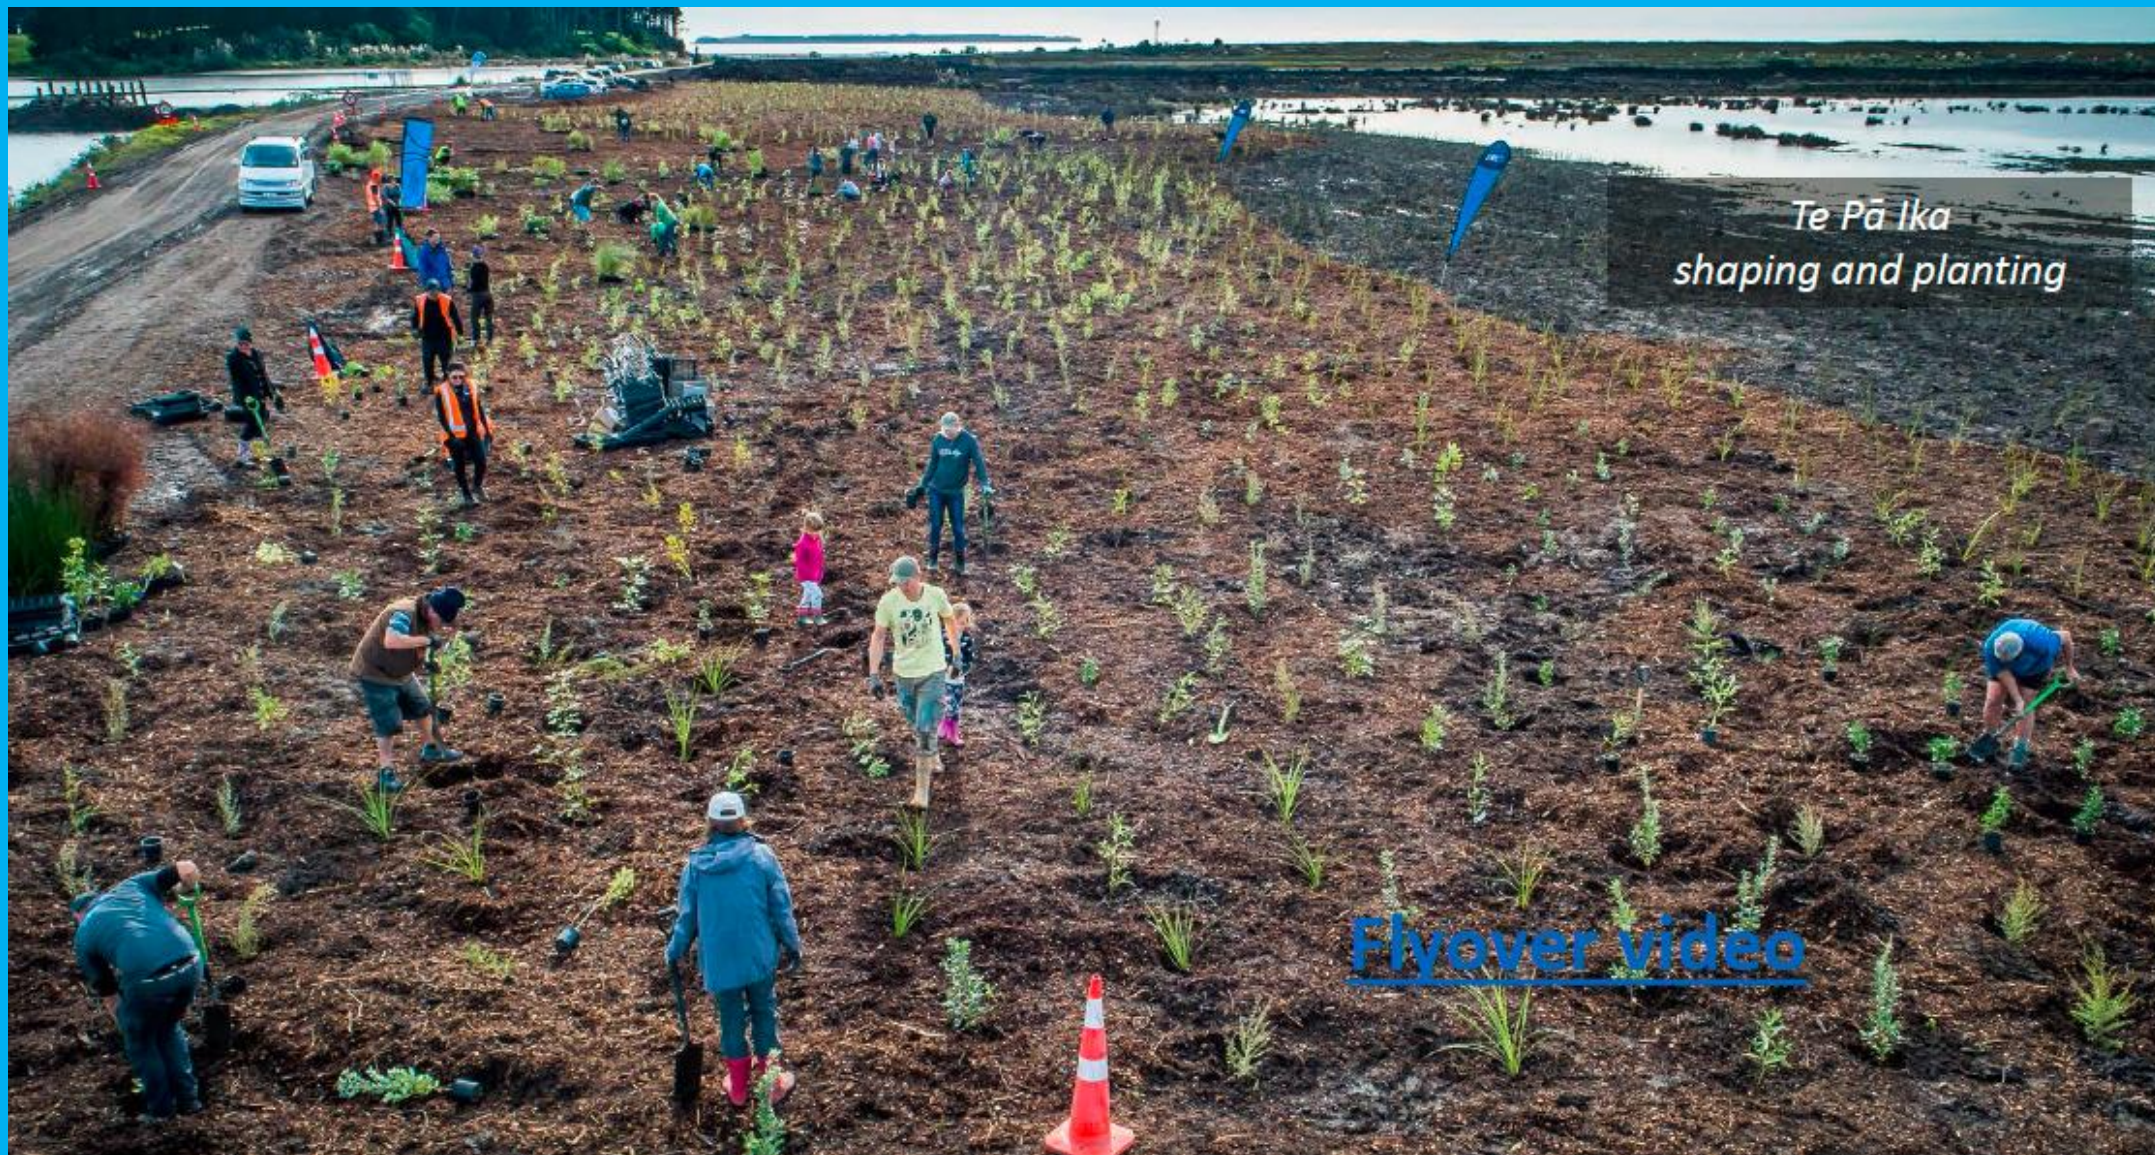
# Chenier

*Te Pā Ika  
shaping and planting*

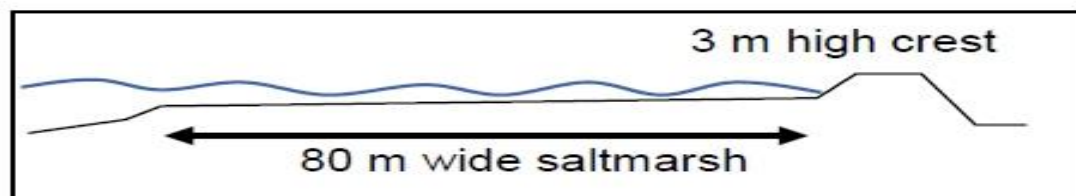
# Sea Defence Costs with Differing Widths of Saltmarsh (south east UK - early 1990's)

Cost £400/m of seawall

Cost £500/m of seawall

Cost £800/m of seawall

Cost £1500/m of seawall

Cost £5000/m of seawall

Indicative costs and heights of sea defences with different widths of saltmarsh fronting. Costs presented in early 1990s prices. Information drawn from south east England

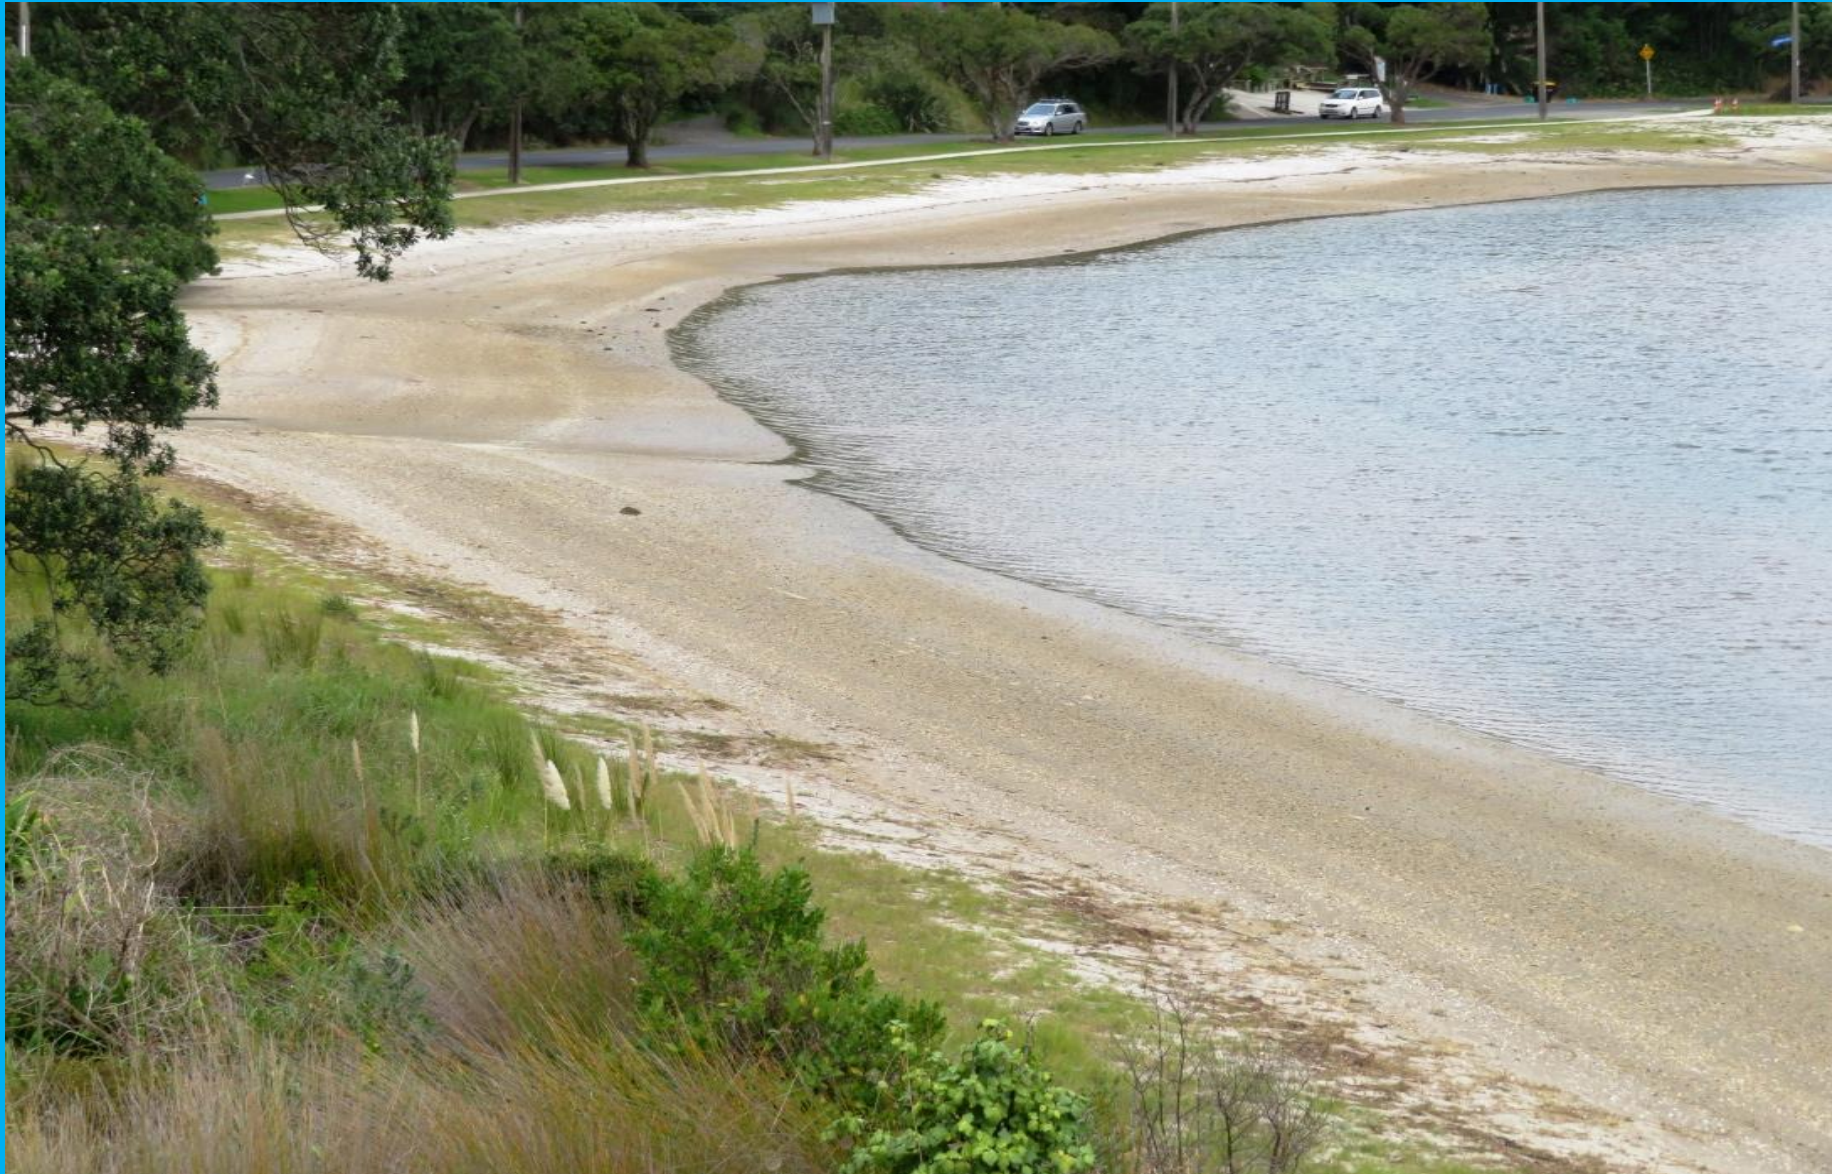
# Estuarine Beach formed by Nourishment

(Tairua Harbour, Coromandel)

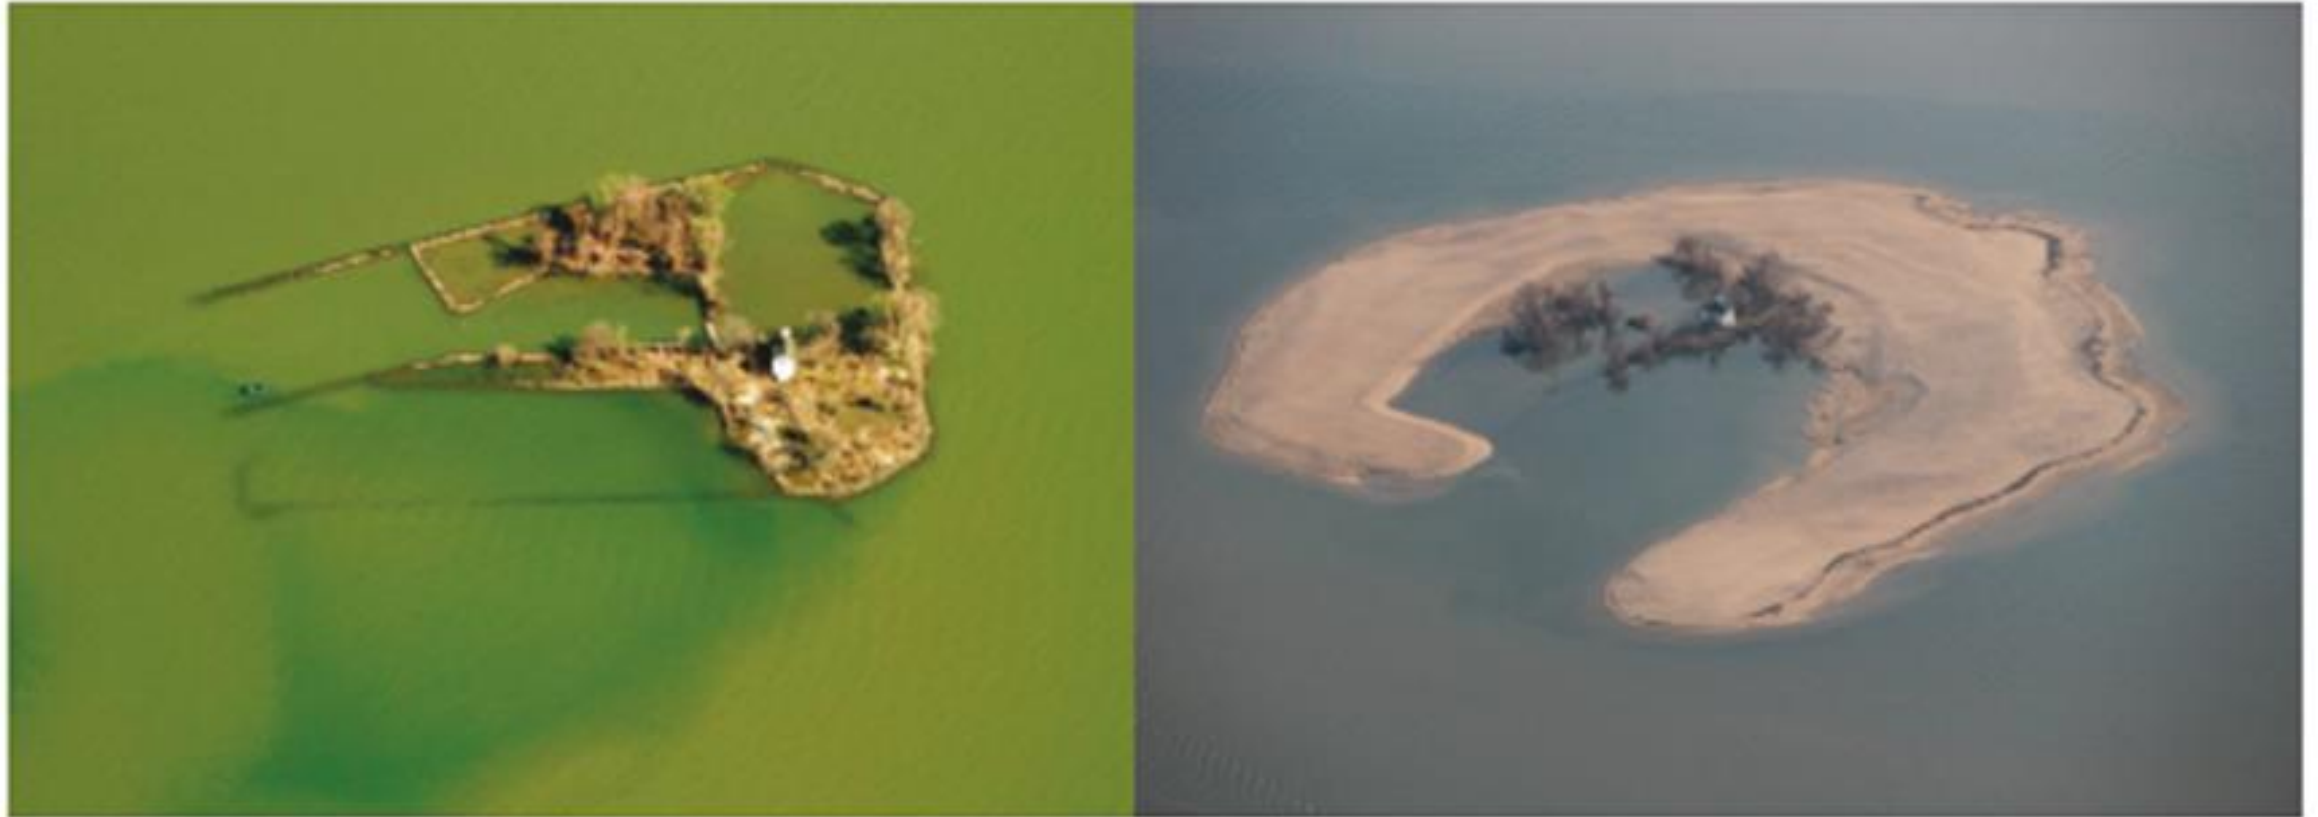
# Battery Island – Before & After

Figure 7. Battery Island before (left; 2011) and after (right; 2013) unconfined placement of dredge material

- Primary objective was to beneficially use dredged material to restore an eroded waterfowl nesting site and historic lighthouse in the Susquehanna National Wildlife Refuge, Chesapeake Bay
- Material was dredged from the Susquehanna federal channel at the mouth of the Susquehanna River
- Dredged material was placed hydraulically with a diffuser and distributed by earth moving equipment to create an unconfined horseshoe-shaped island
- This use of dredged material applying working with nature principles was cost-competitive with traditional upland confined placement alternatives.

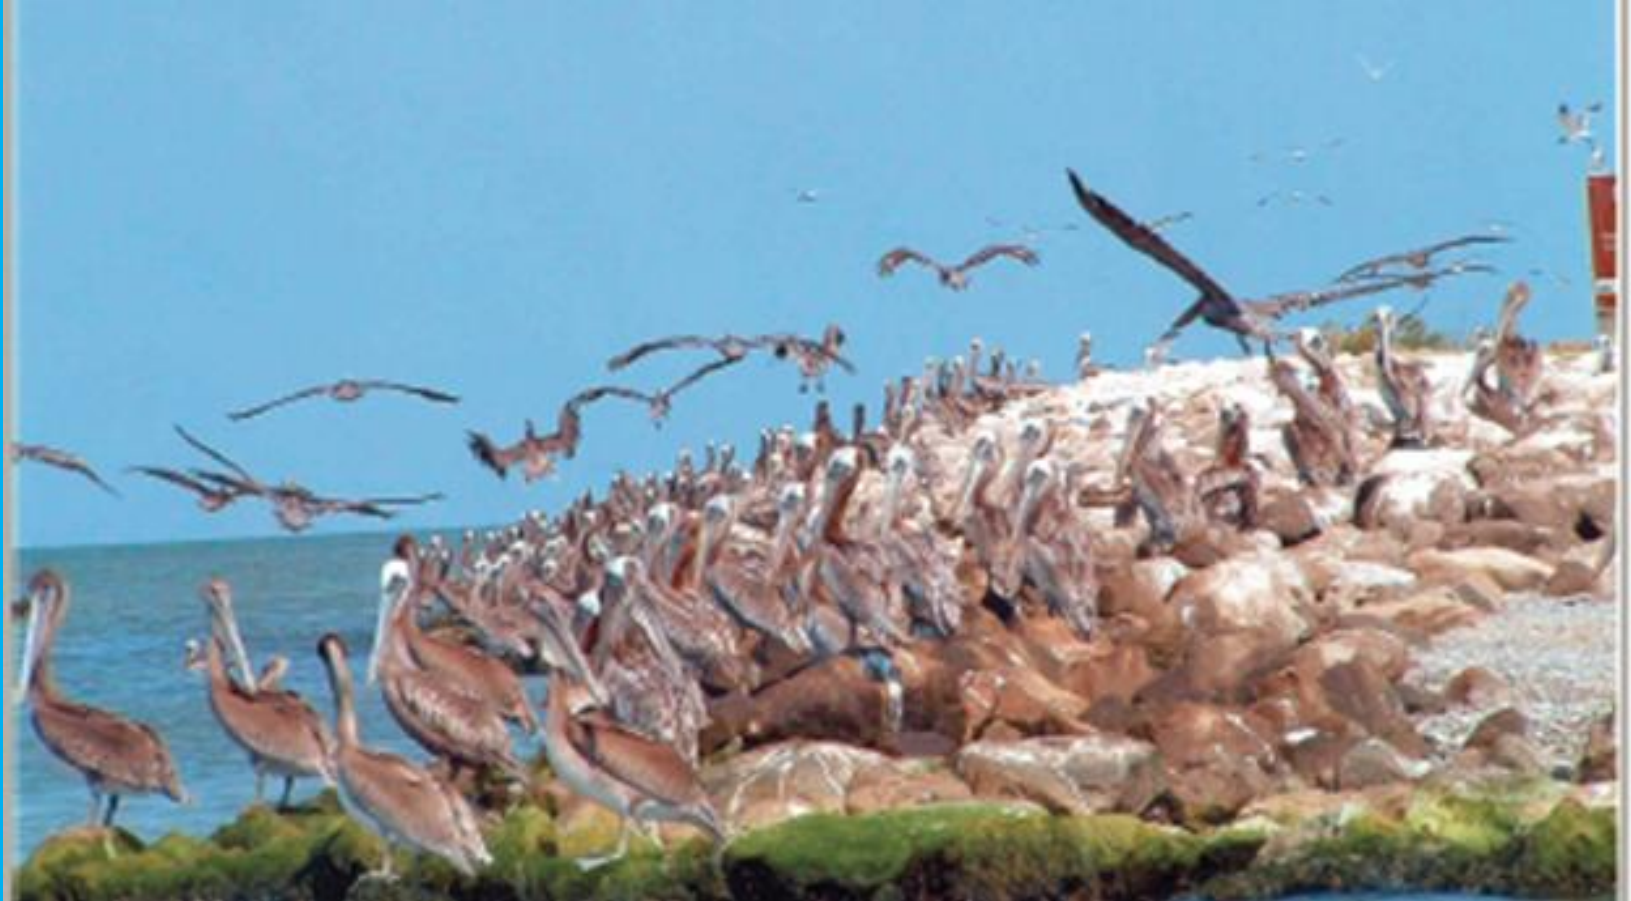
# Elvia Island, Galveston Bay, Texas

Birds making use of the 6 acre island constructed of sediment dredged from the Houston Ship Channel

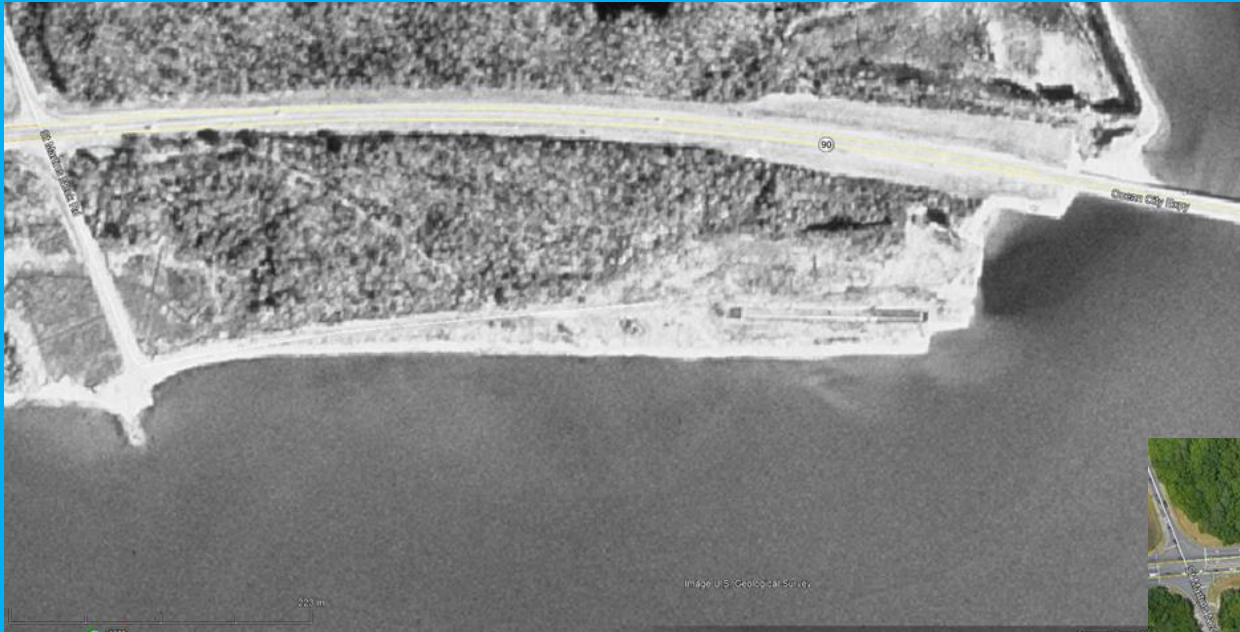
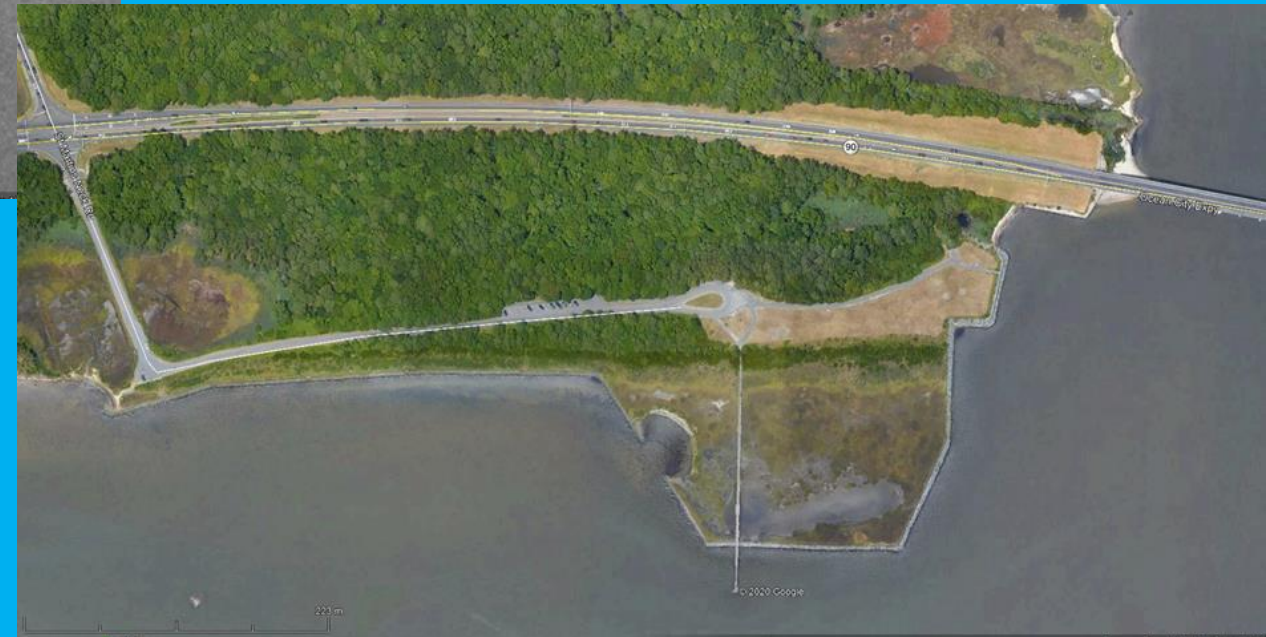
# Before & After

- Isle of Wight Bay Restoration Project, Worcester County, MD.
- Restoration project involved placement of dredged sediment from the Isle of Wight Federal channel to restore salt marsh habitat
- Rubble protection placed to the restored marsh
- The shoreline had eroded at this location, exposing built infrastructure through the loss of marsh habitat
