Coastal Lakes of Southland

Keryn Roberts *Environmental scientist – estuaries and lakes*

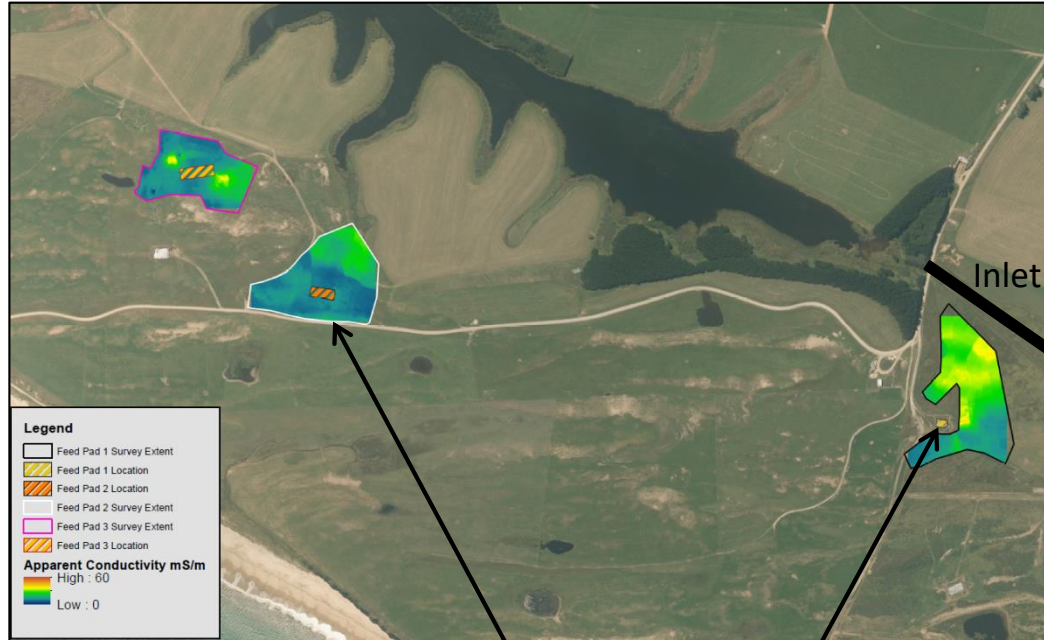
EMI mapping of effluent

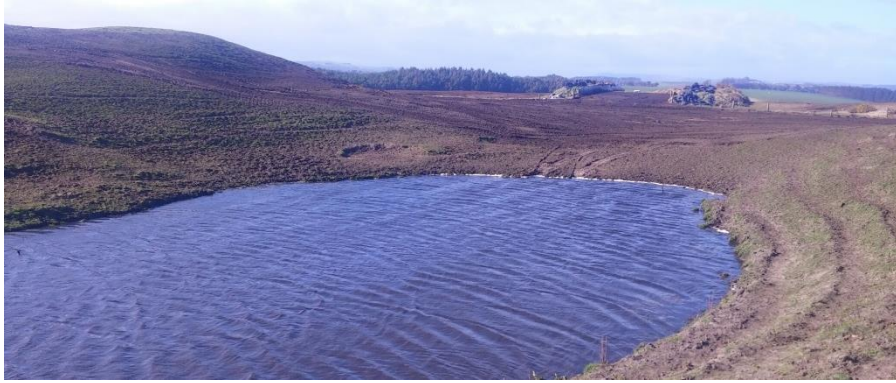
Fencing and exclusion of
stock from lake margins

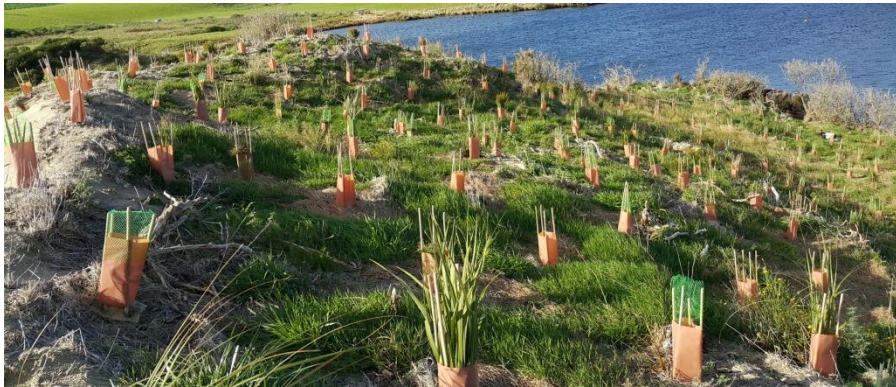
Riparian planting

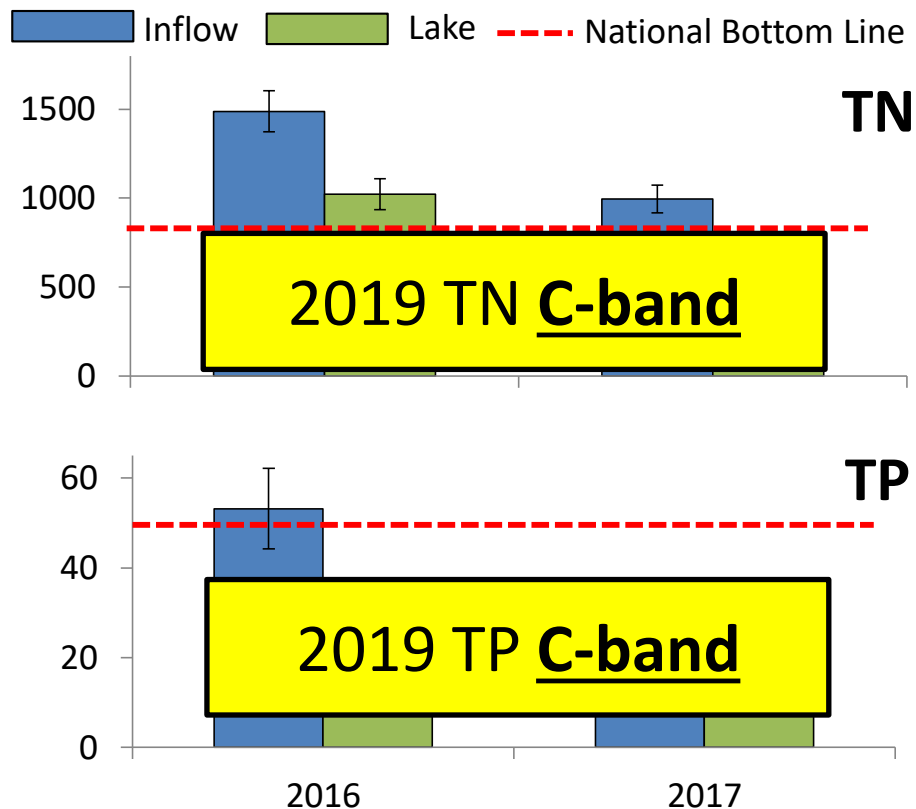
- Improved land use management
- Lower TN and TP for 2017 compared to 2016*

*too soon for trend analysis

^concentration in mg/m³. Data is mean ± SE
