AUCKLAND

DO SHORT-TERM CLIFF-EROSION MEASUREMENTS RELIABLY REPRESENT LONG- TERM EROSION RATES?

Presented by Lovleen Acharya Chowdhury

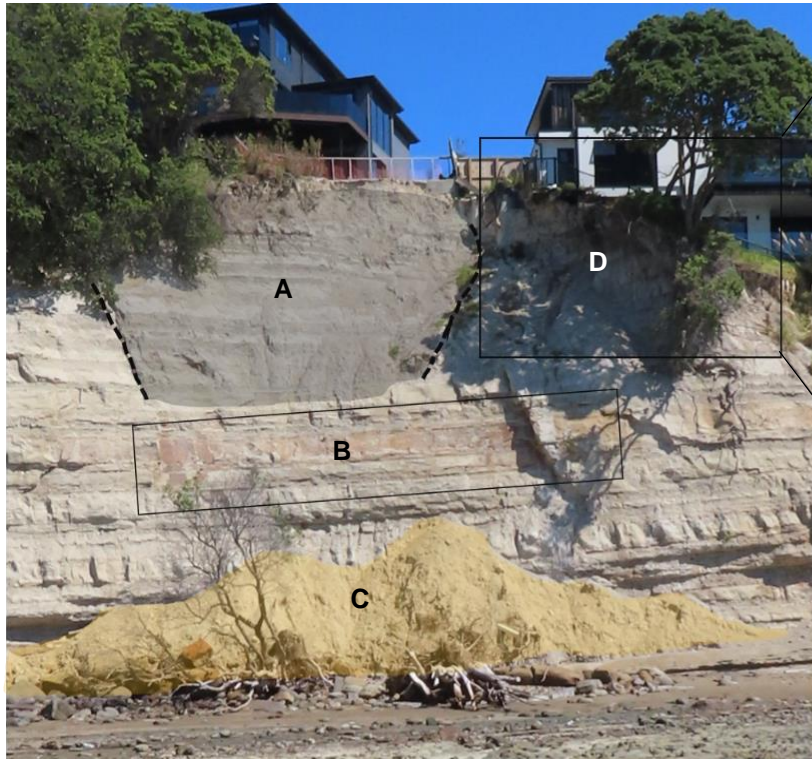
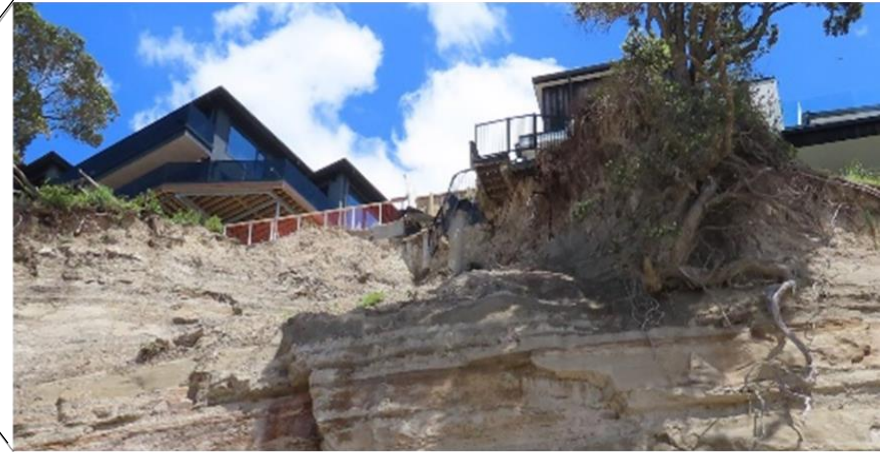
A) Location of the wedge failure with its associated vertical jointed surface/failure plane (black dashed lines). B) Failure of sandstone bedding plane C) Talus formed due to the accumulation of the debris supplied by the two failures above. D) Collapse of weathered soil at the cliff top has exposed the Pōhutukawa tree root system and foundations of the properties. A properties' deck can be seen hanging mid-air.
